Report to Perry Township Schools School Board

High Schools Facility Assessment

Perry Township Schools

January 17, 2025

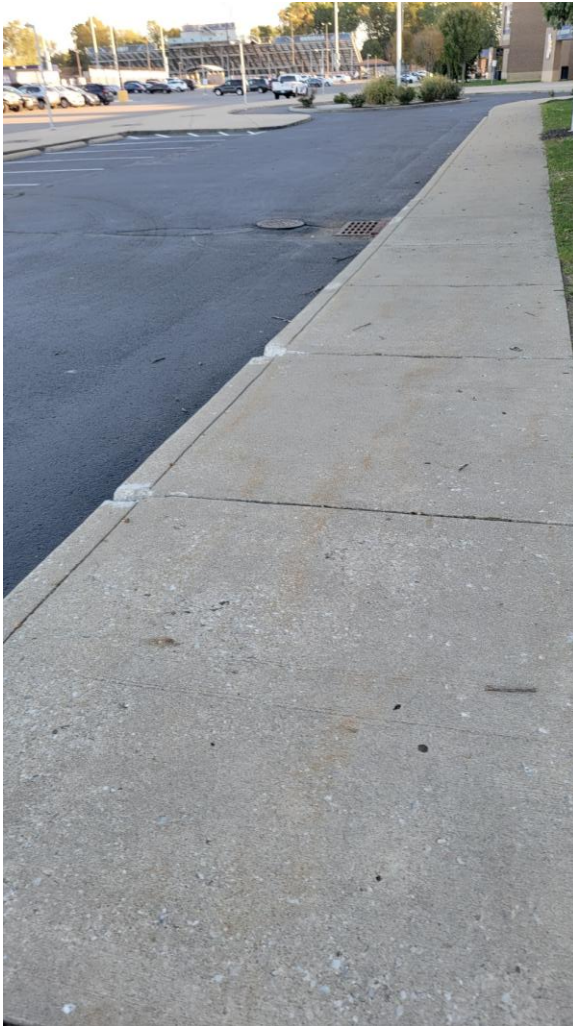
Wear and tear of concrete sidewalks

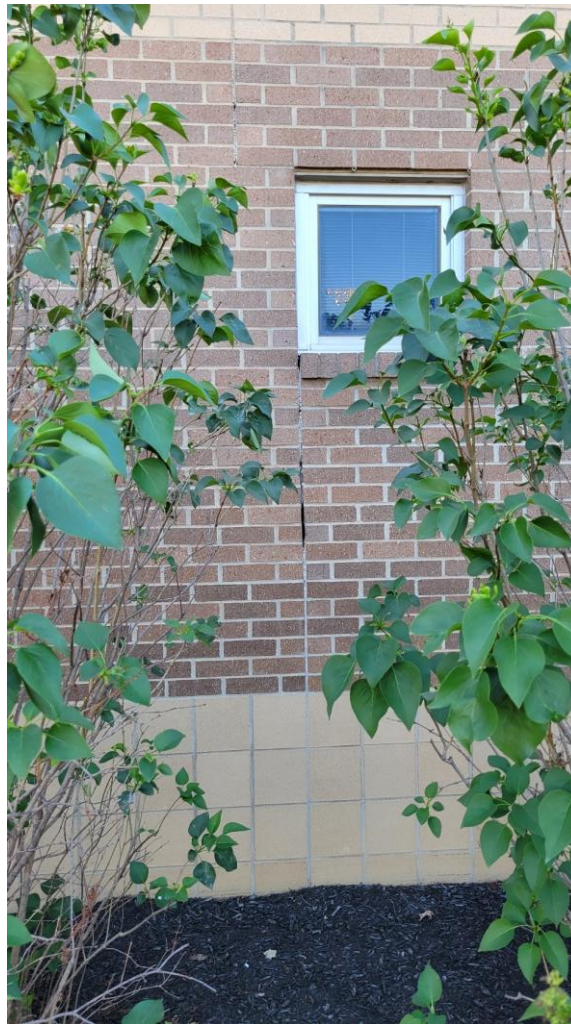
Failing caulk joint

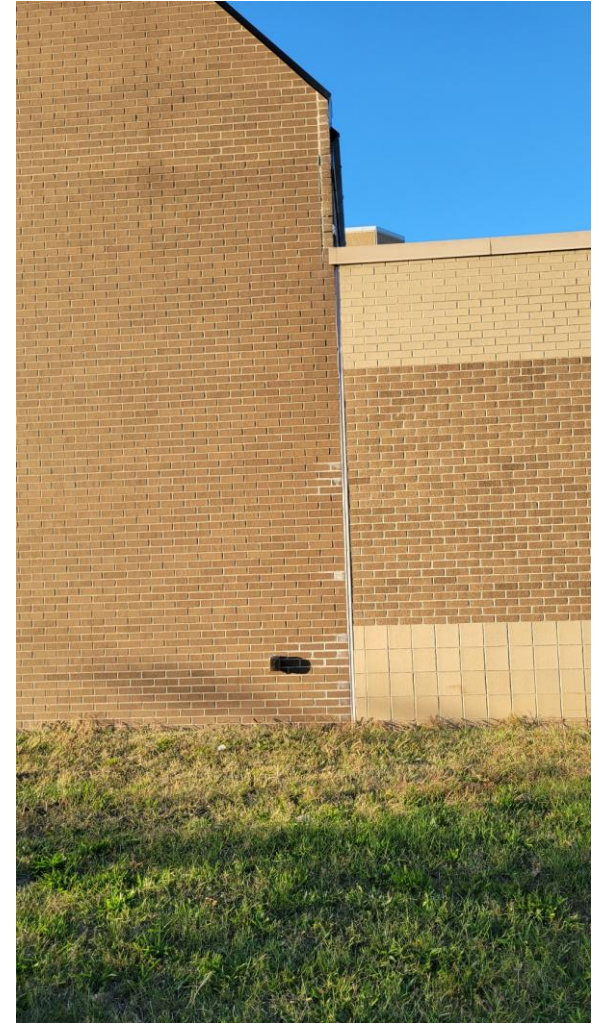
Expansion joint out of plumb

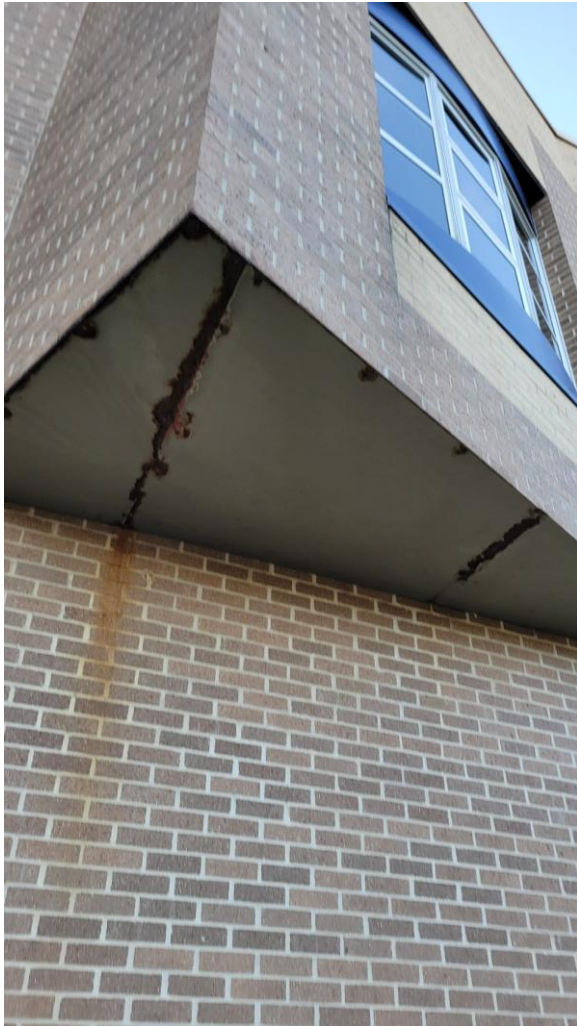
Rusting soffit under weight room

7. Replacement of masonry caulk joints and tuckpointing, (2 story wing 1,250 LF, west side of main gym 185 LF, south side of the auditorium 165LF) rusting soffit under the current weight room (900 SF)

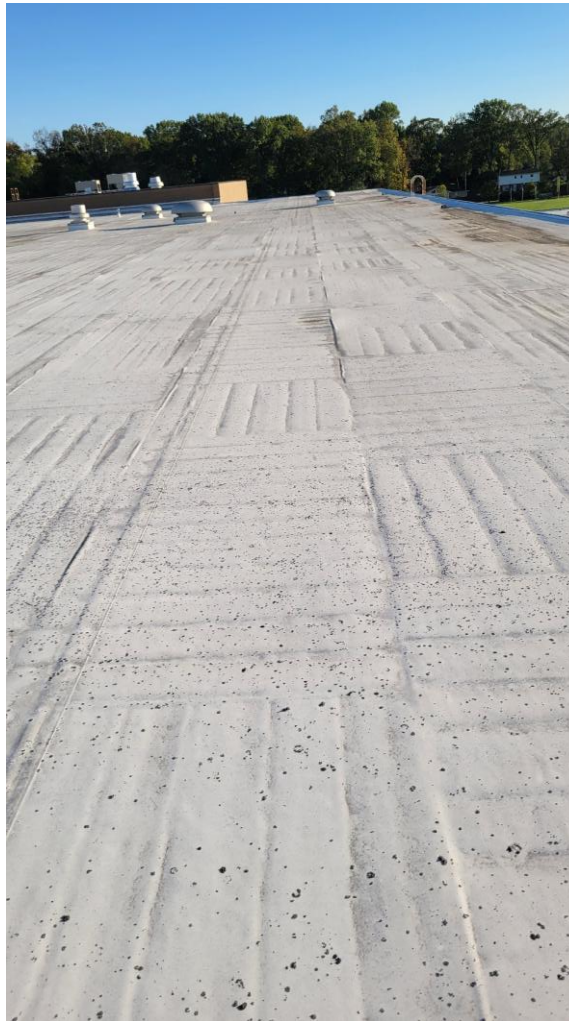
Aging roof

8. Roofing replacement (145,000 SF down to the deck)
9. 1. Mechanical renovation of the existing chilled water and heating water systems is recommended. It is recommended that renovating to remove the water cooled chilled water system with cooling towers and replace that with air cooled packaged chillers or split system air cooled chillers. It is recommended that new high efficiency condensing boilers should be installed to replace the inefficient fire-tube type boilers. The existing chilled water capacity is 1200-tons. The existing heating boiler capacity is 40 million BTU/h.

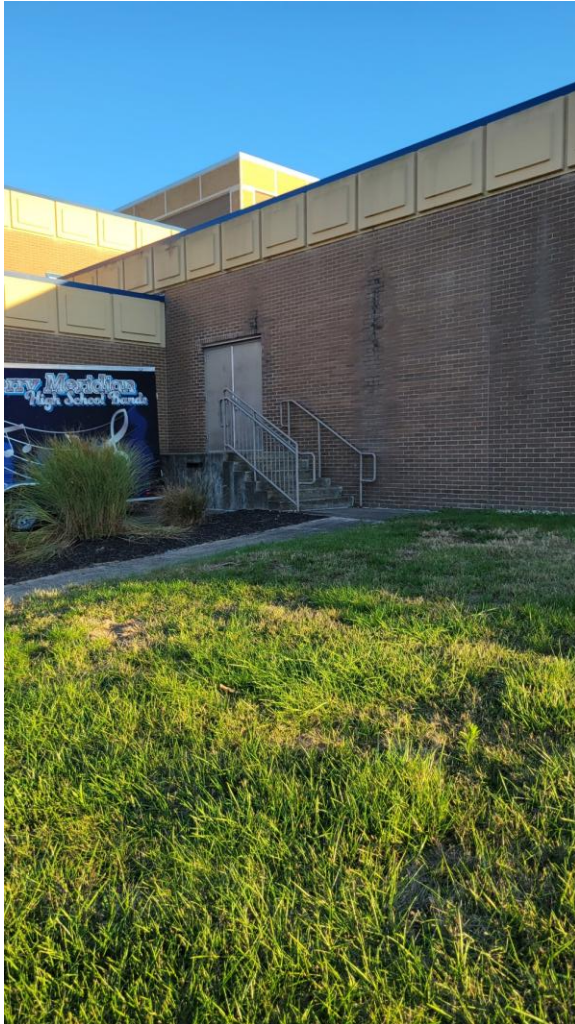
Water damage on the brick

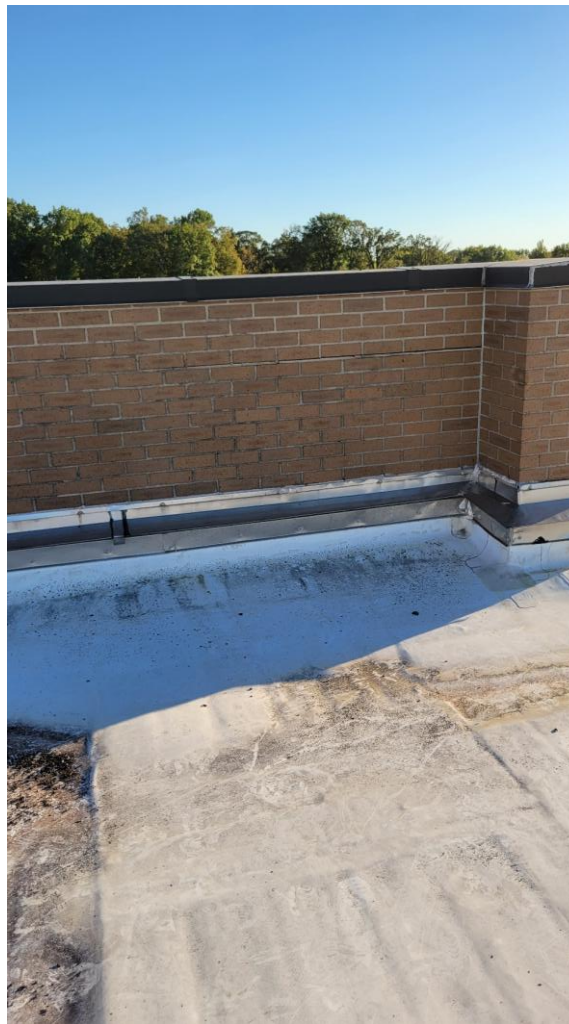
Loose mortar on parapet wall

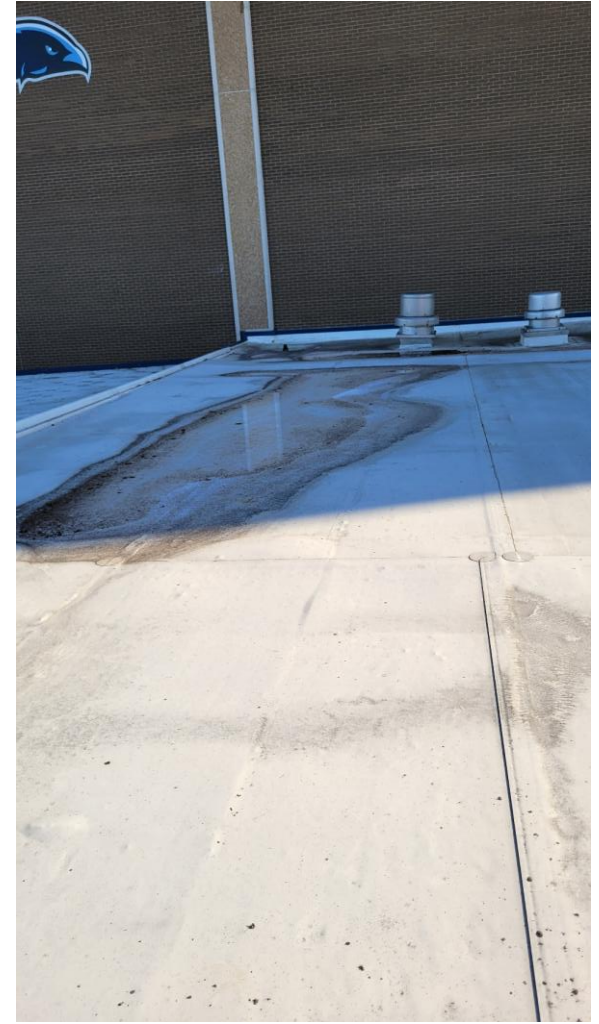
Water ponding on the roof

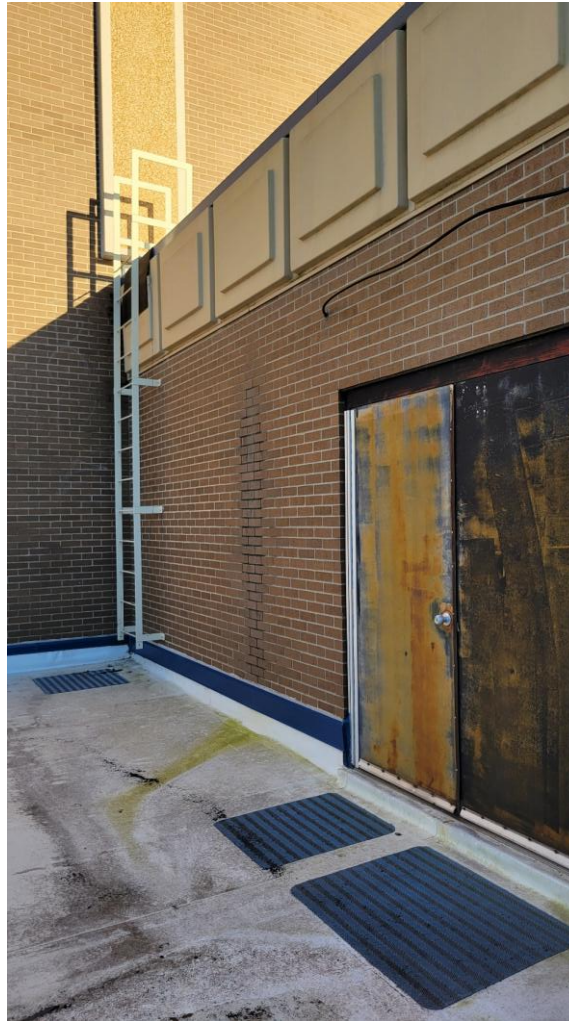
Rusting door at exterior

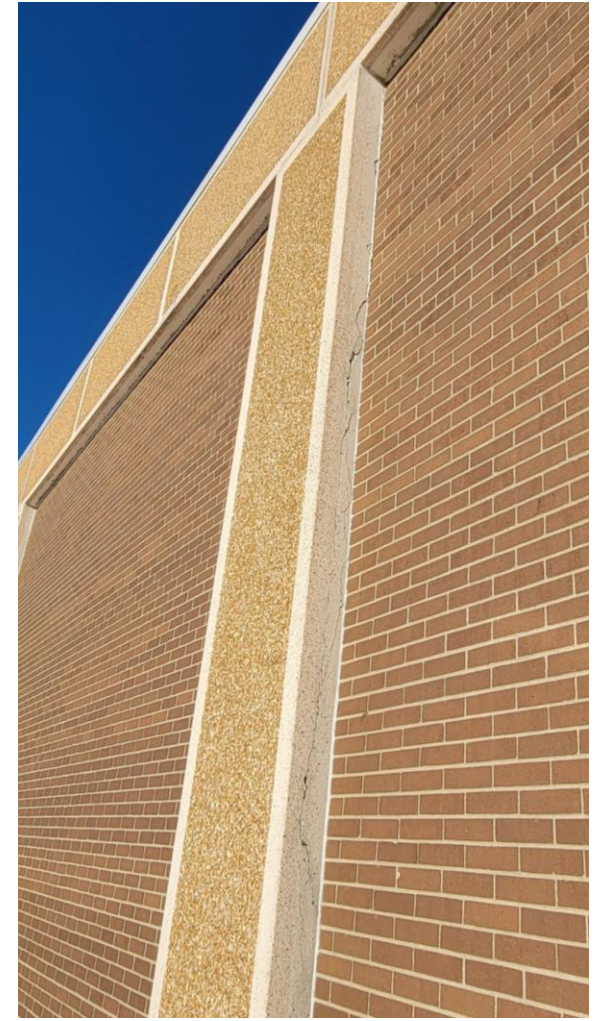
Cracks on the exterior of the main gym pilasters

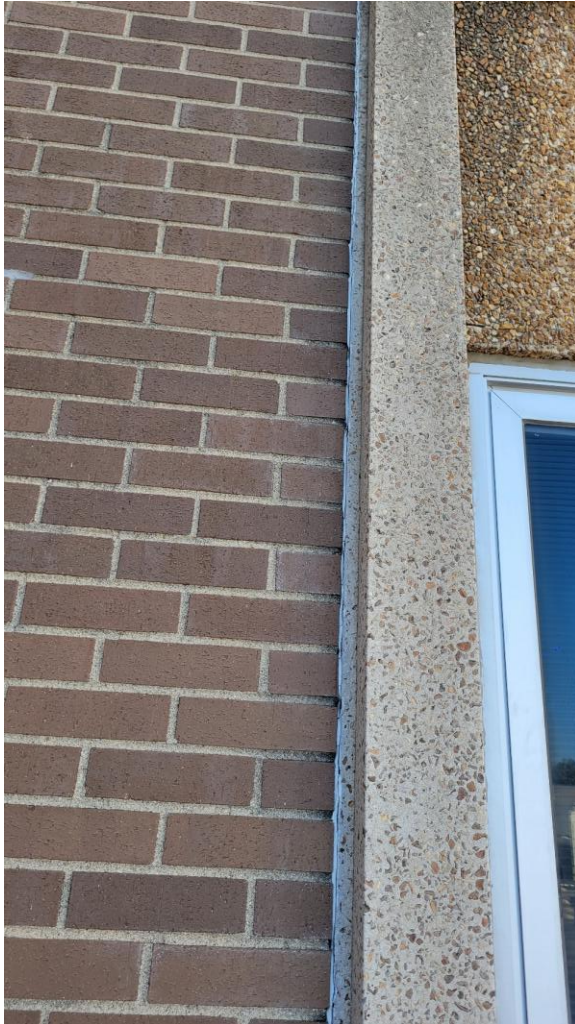
Cracking caulk joint around window openings

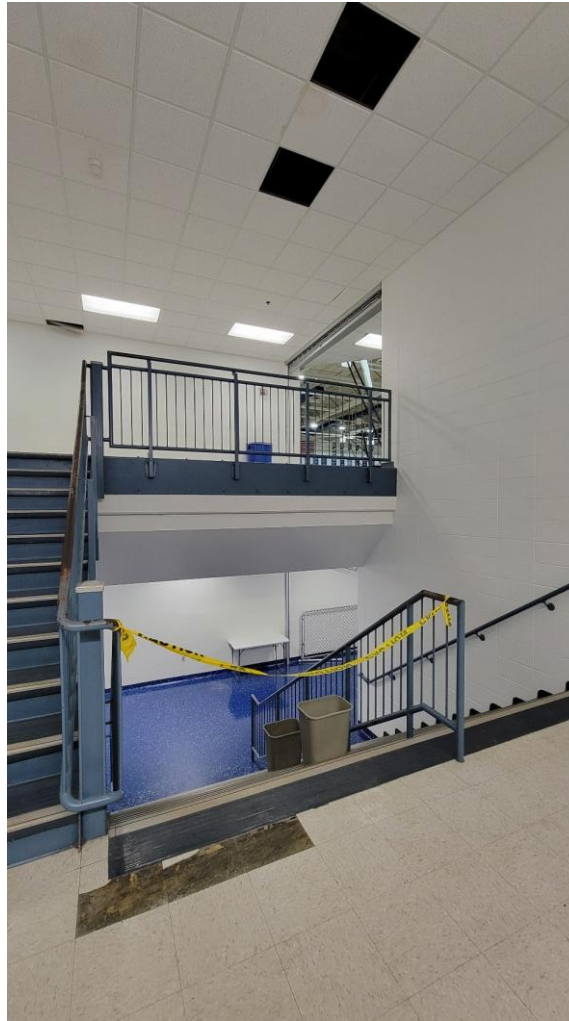
Active leaks during the site visit

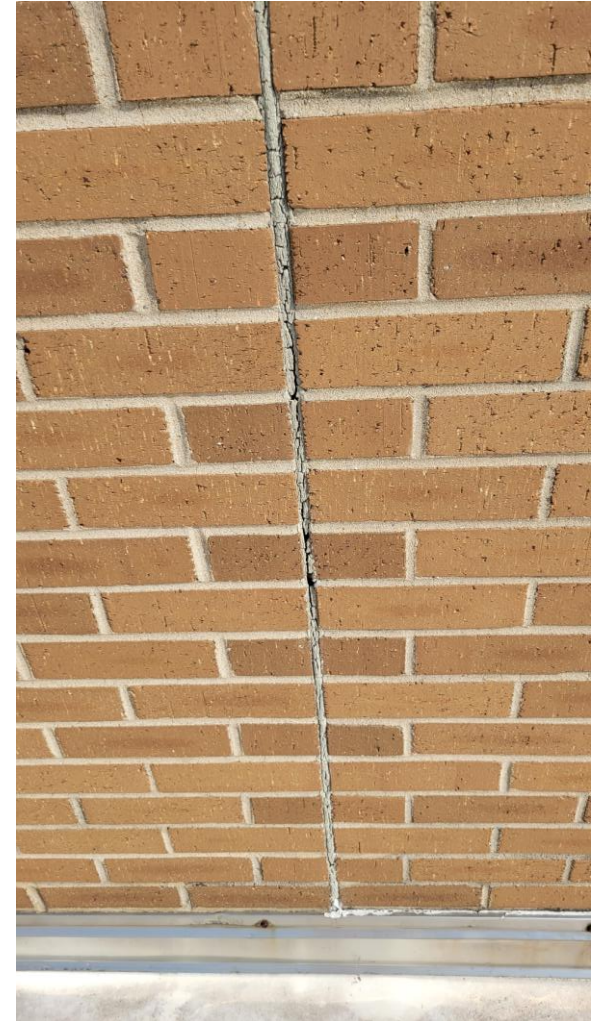
Failing Caulk Joint

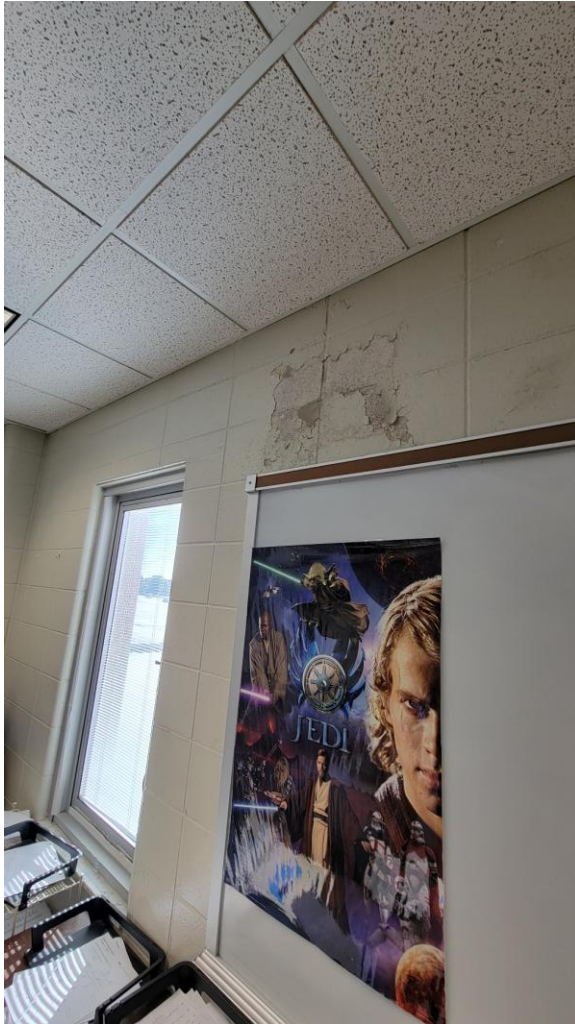
Moisture infiltration on exterior wall in classroom

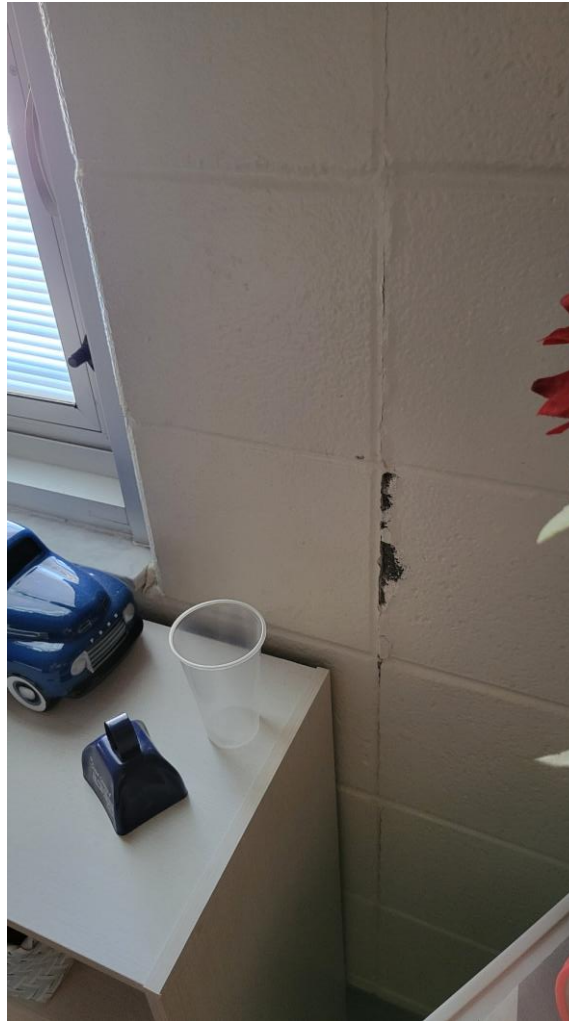
Moisture infiltration on exterior wall in classroom

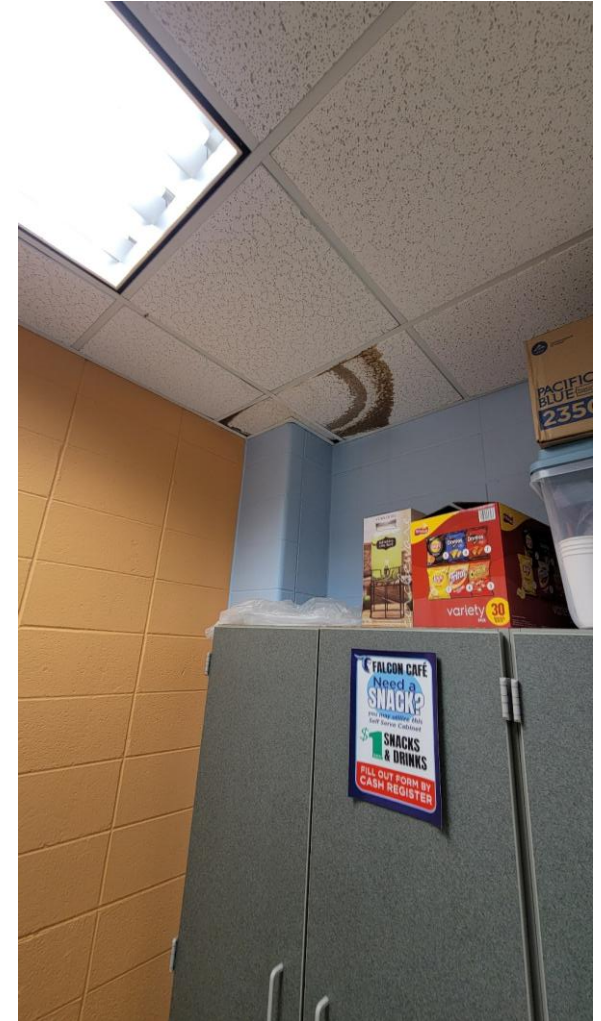
Example of a previous roof leak

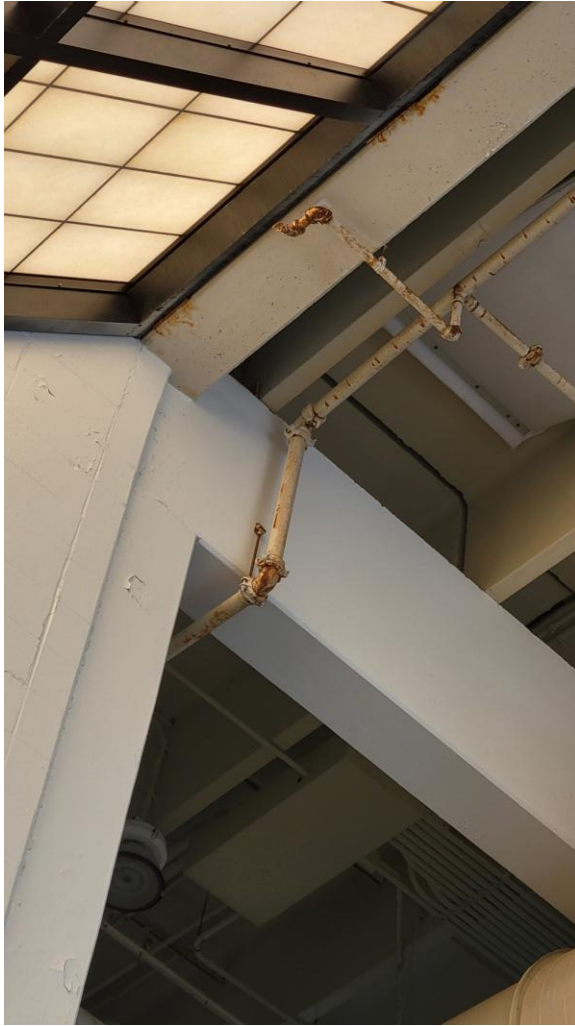
Pool rusting piping, peeling paint and yellowing skylight

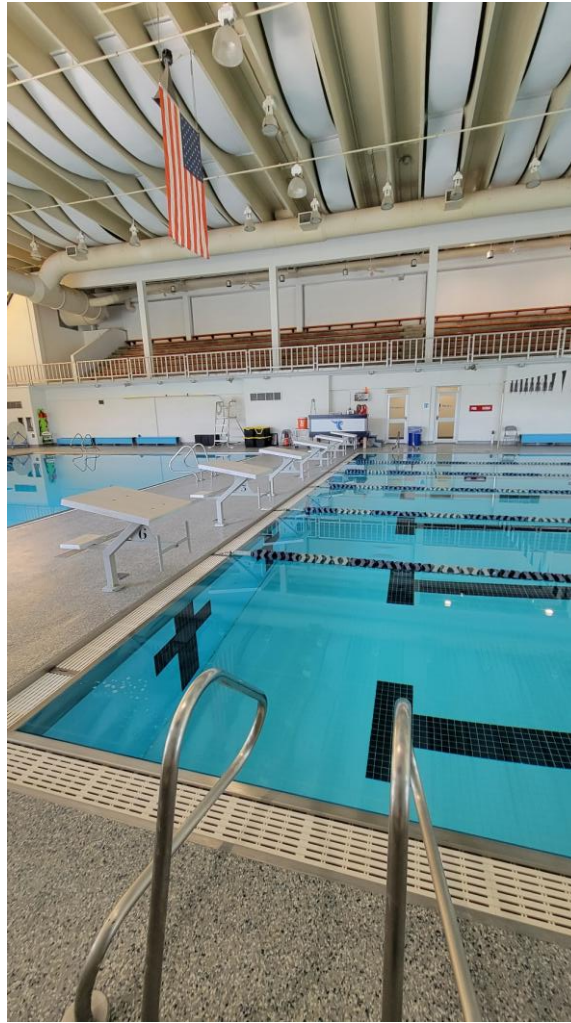
6 lane pool not suitable for competitions

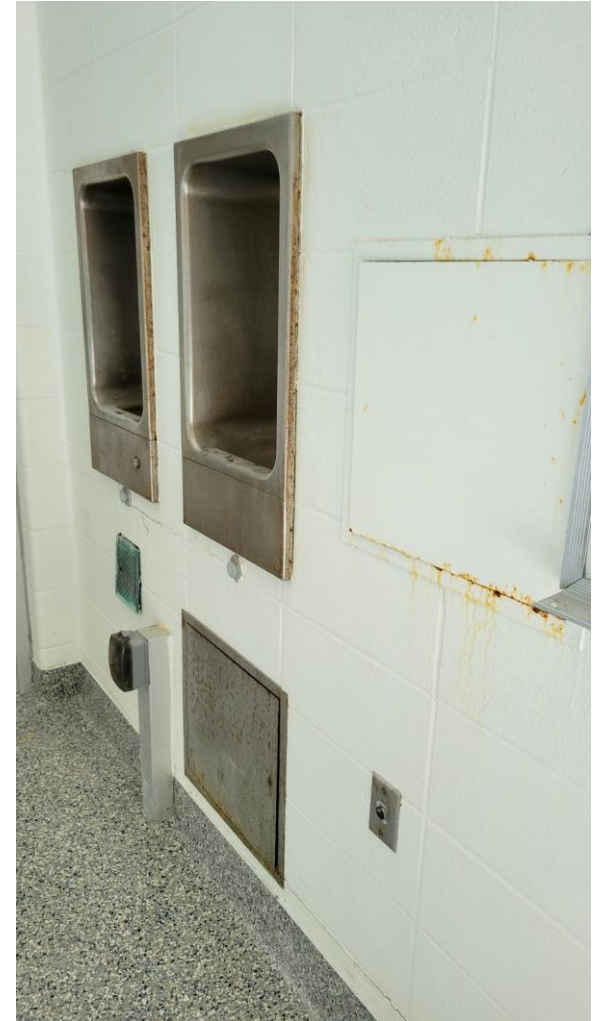
Rusting steel elements in the pool

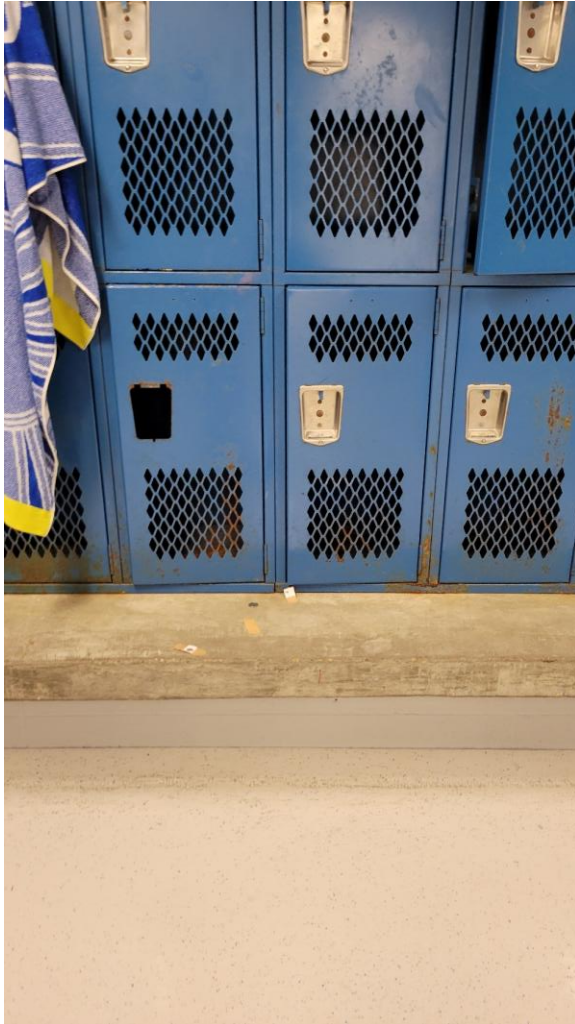
Rusting lockers in the pool locker room

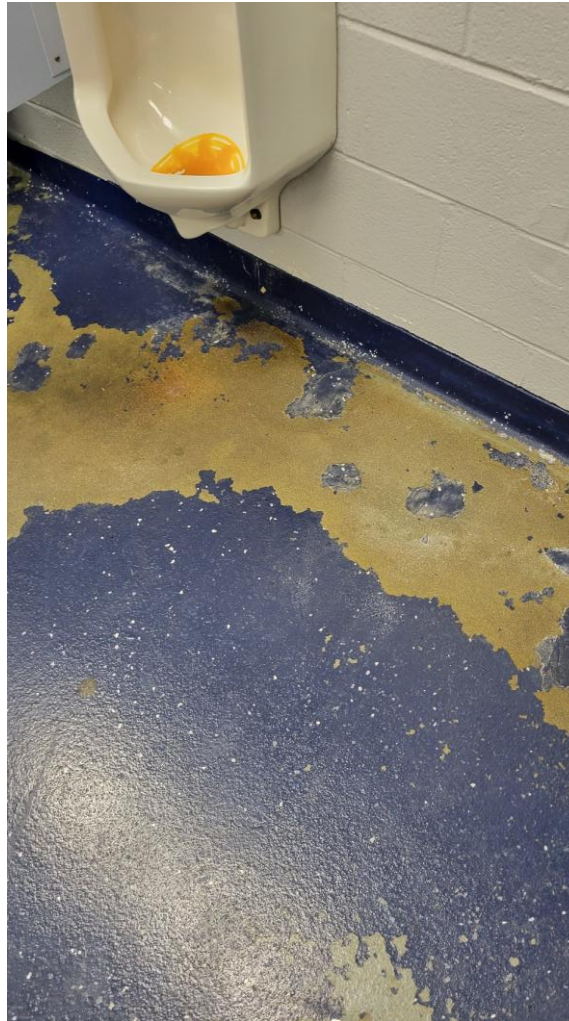
Worn epoxy flooring in wrestling locker room

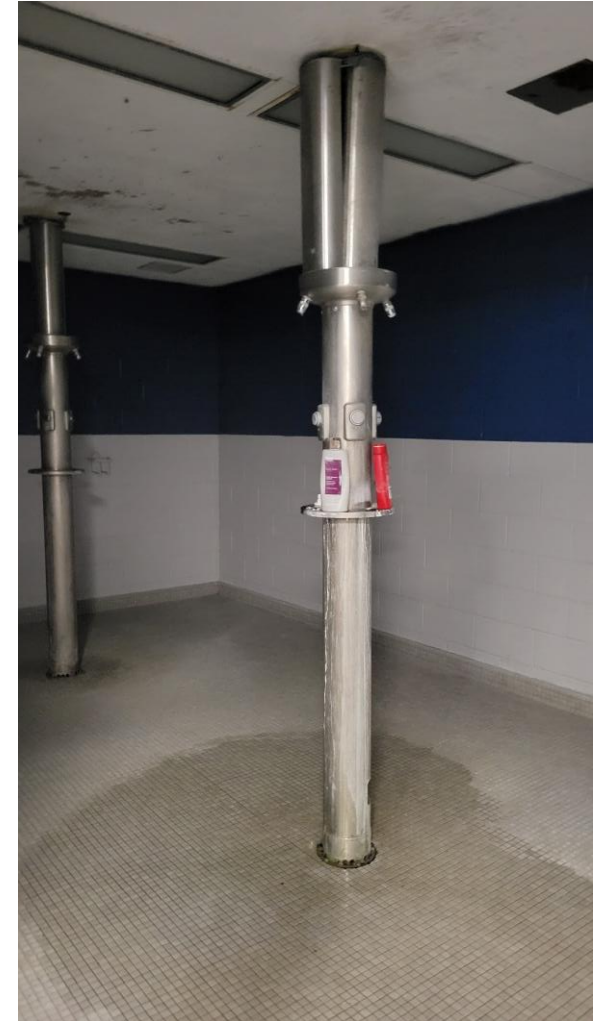
Leaking gang showers, worn ceilings in the locker rooms

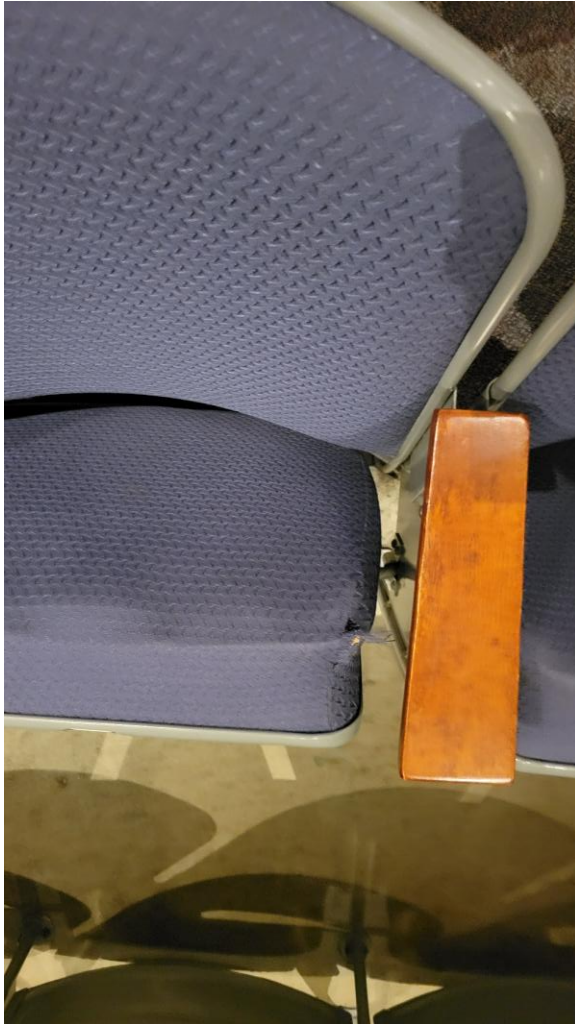
Worn seat in the Auditorium

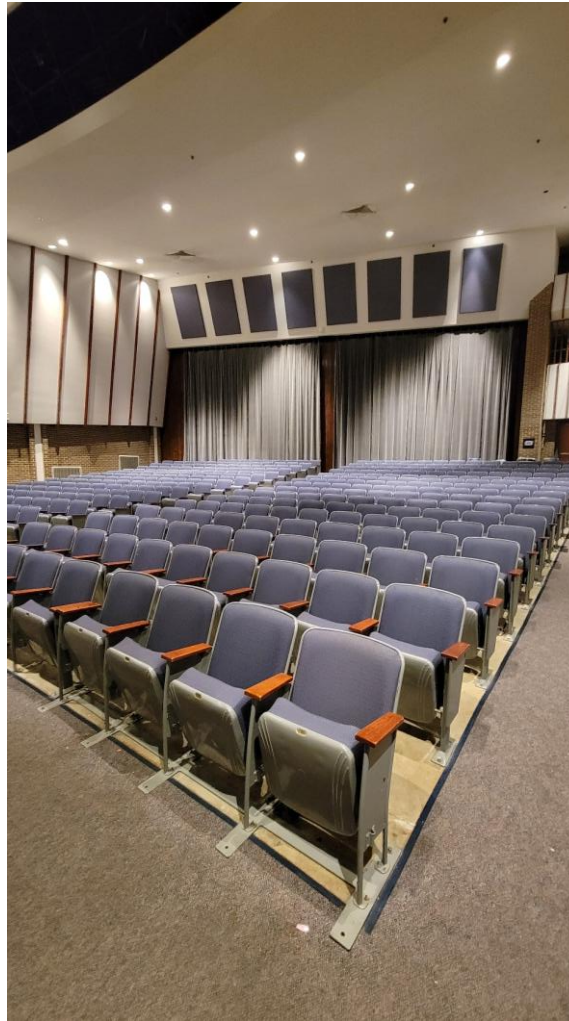
Worn carpet in the auditorium

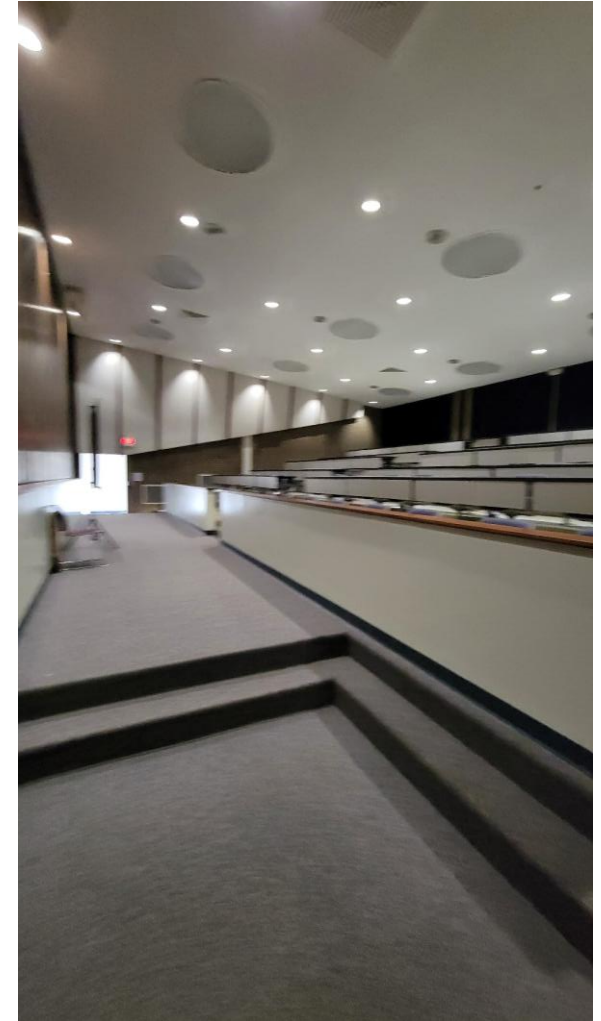
Non-accessible entrance in the wings of the auditorium

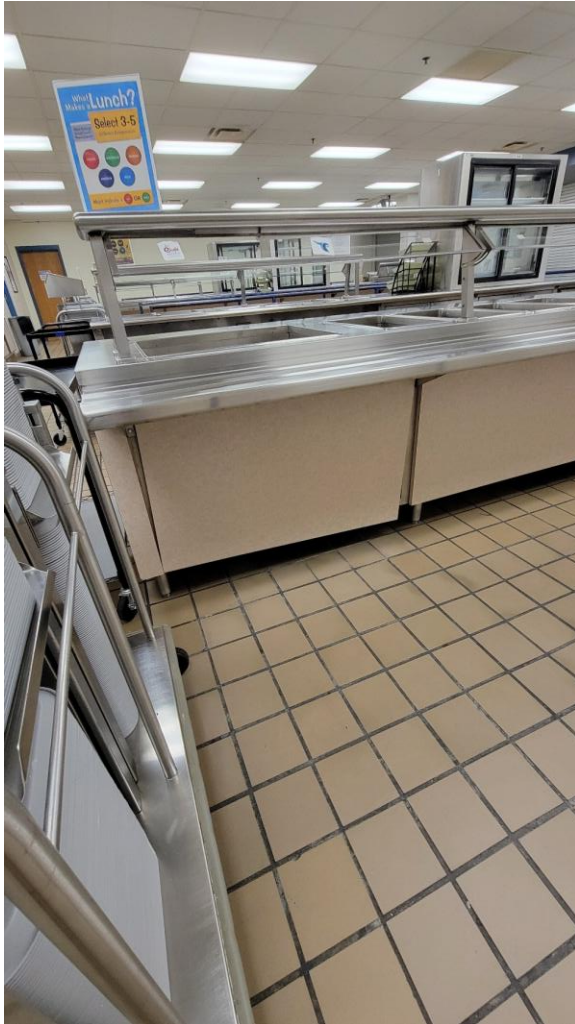
Serving area loose plastic laminate panels

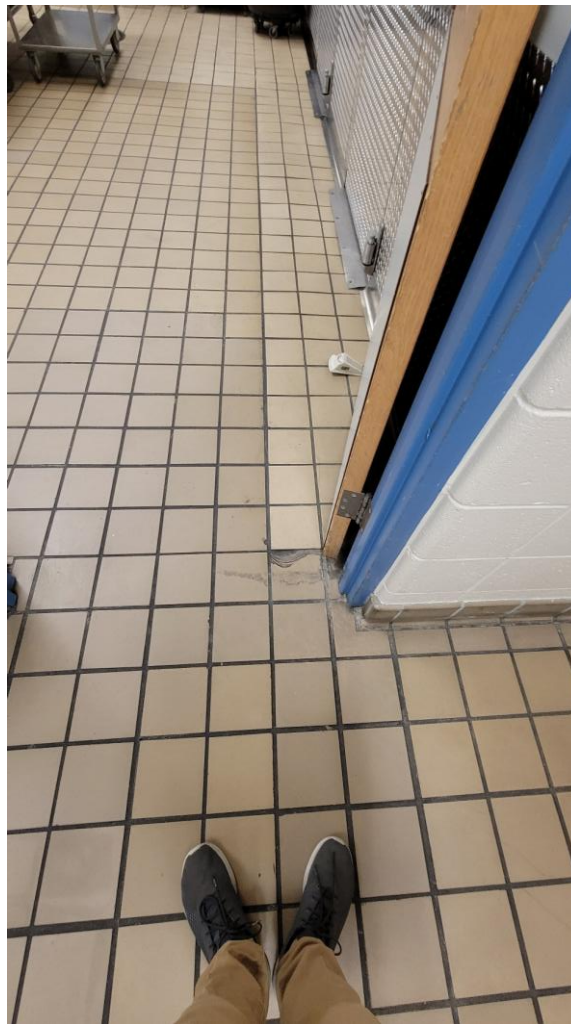
Cracked tile in the kitchen area

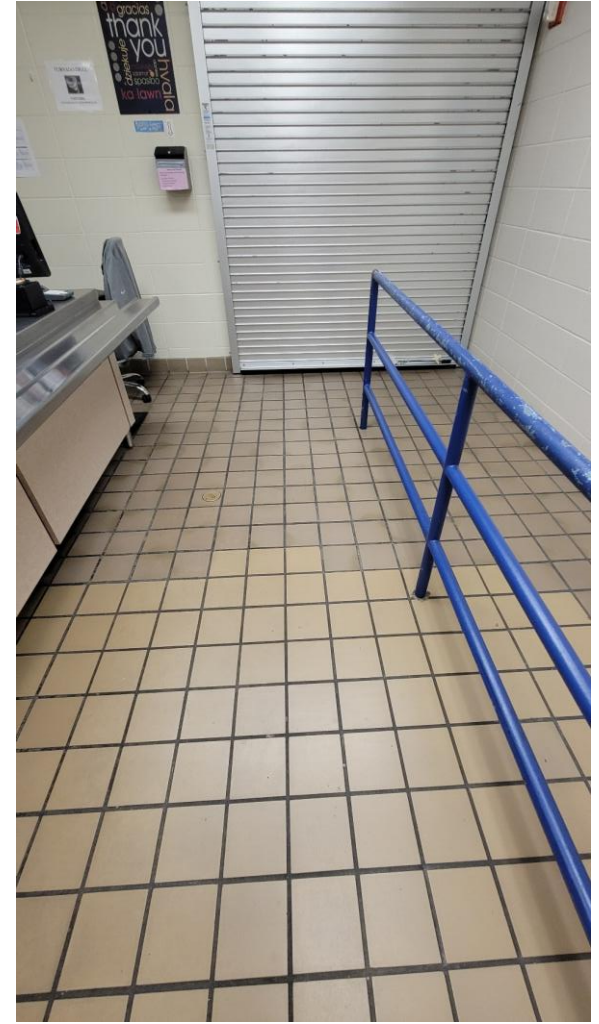
Peeling paint, mismatched floor tile colors

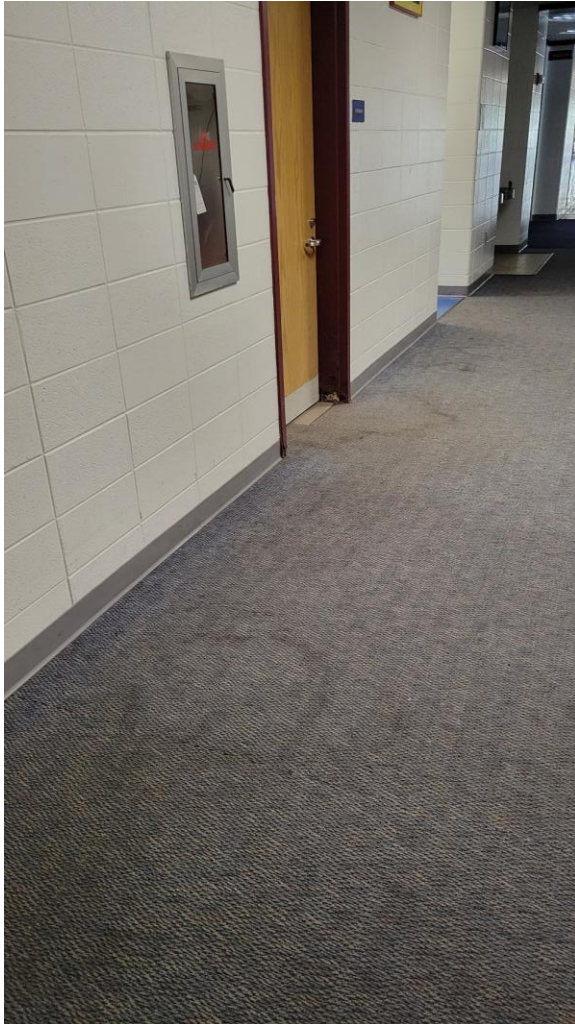
Stained Carpet

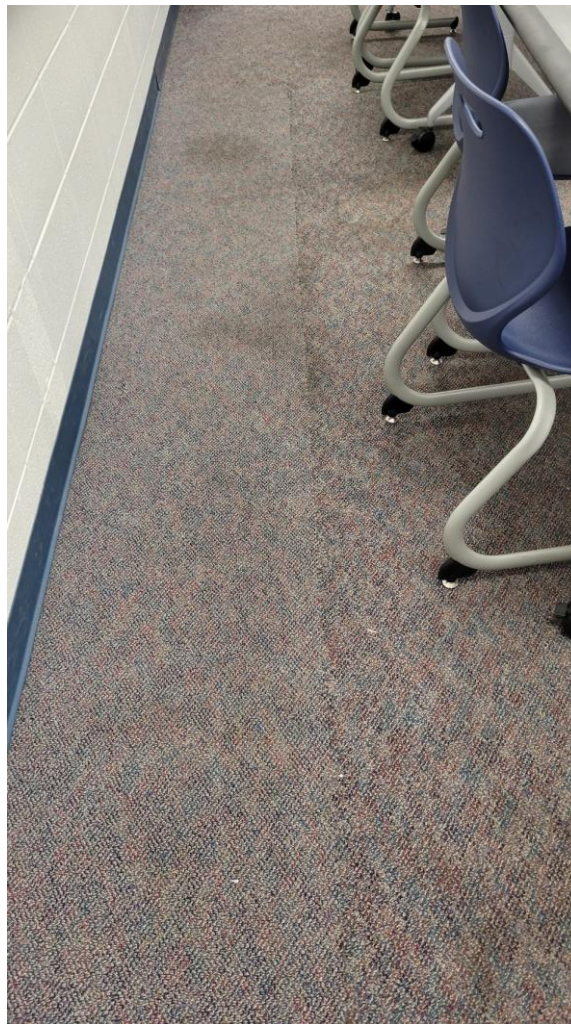
Visible seam in the carpet (possible future tripping hazard)

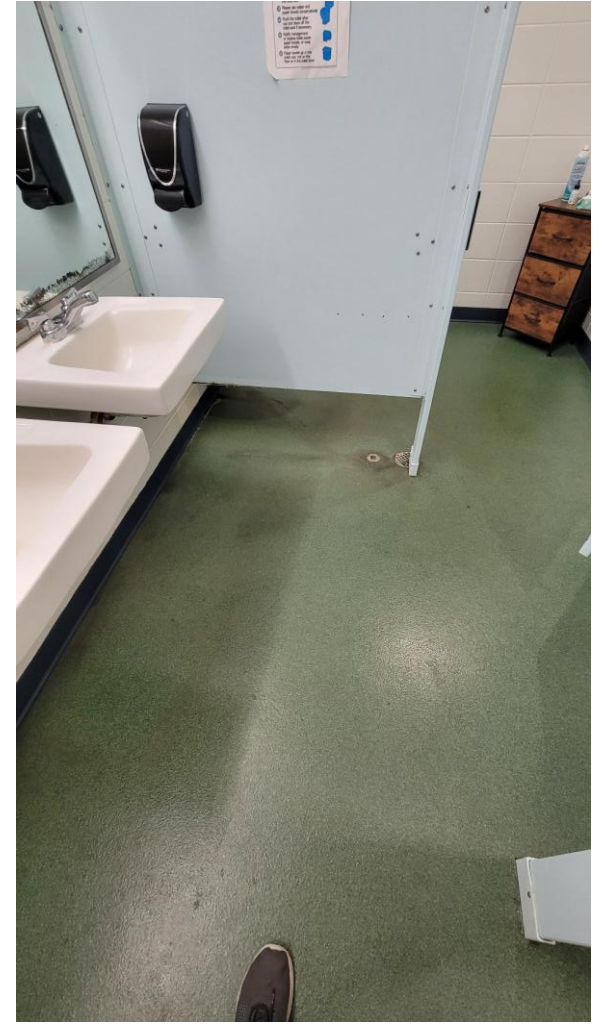
Worn flooring in restroom in admin area

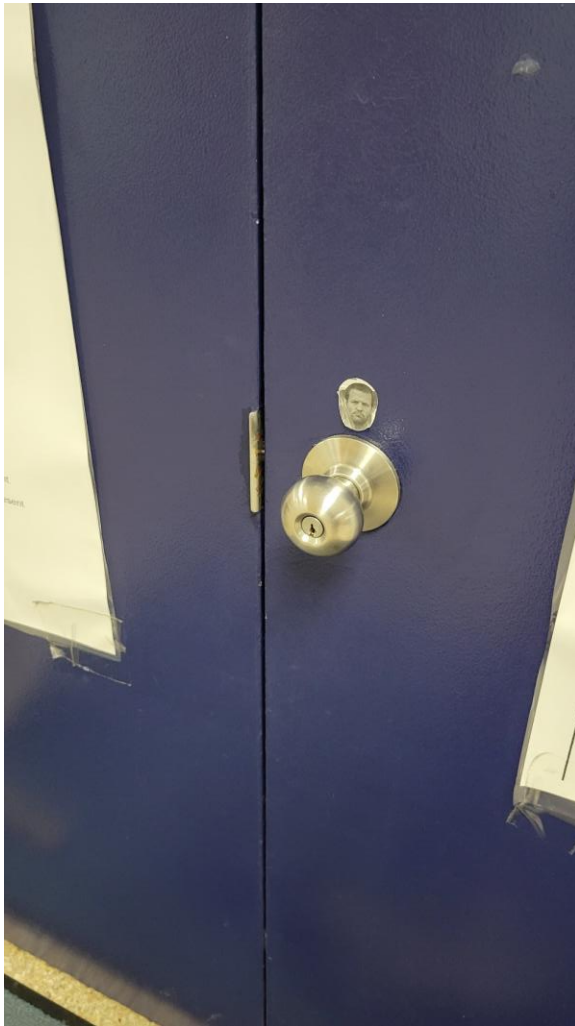
Non-ADA door handle

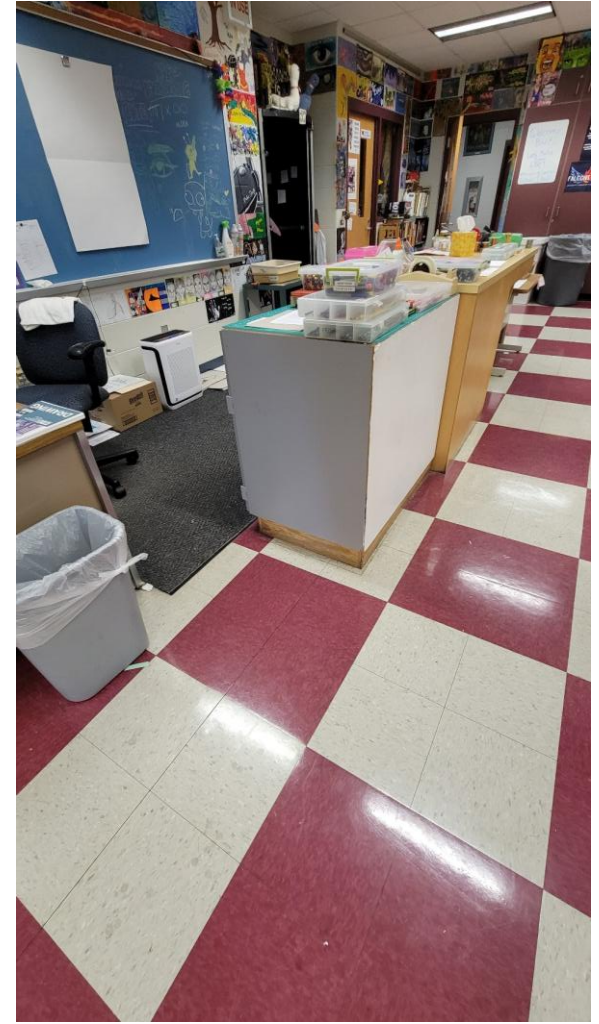
Worn casework and lack of storage in art classroom

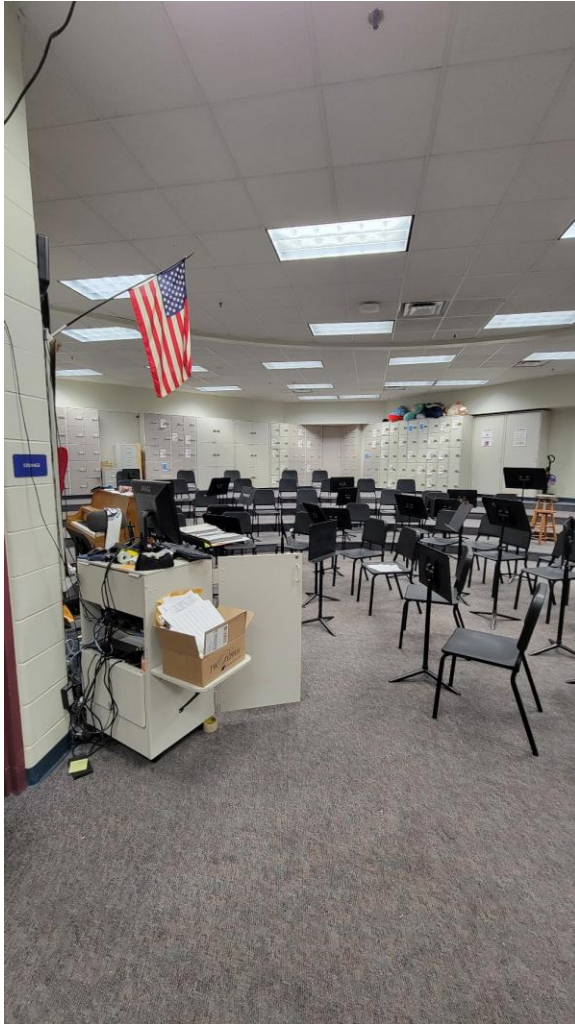
Low ceiling in performing arts classroom

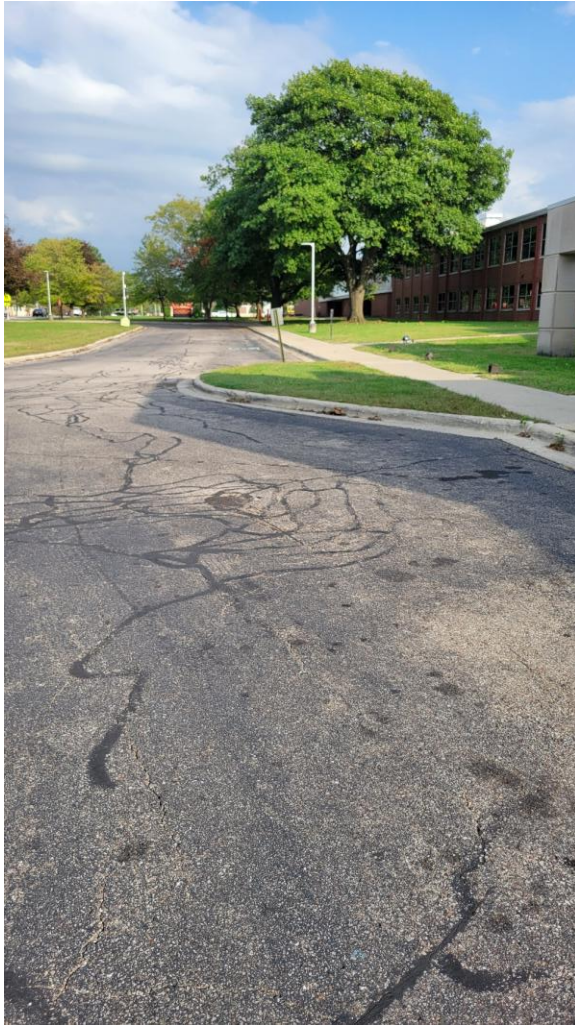
Cracking Asphalt on the north and east sides of the building

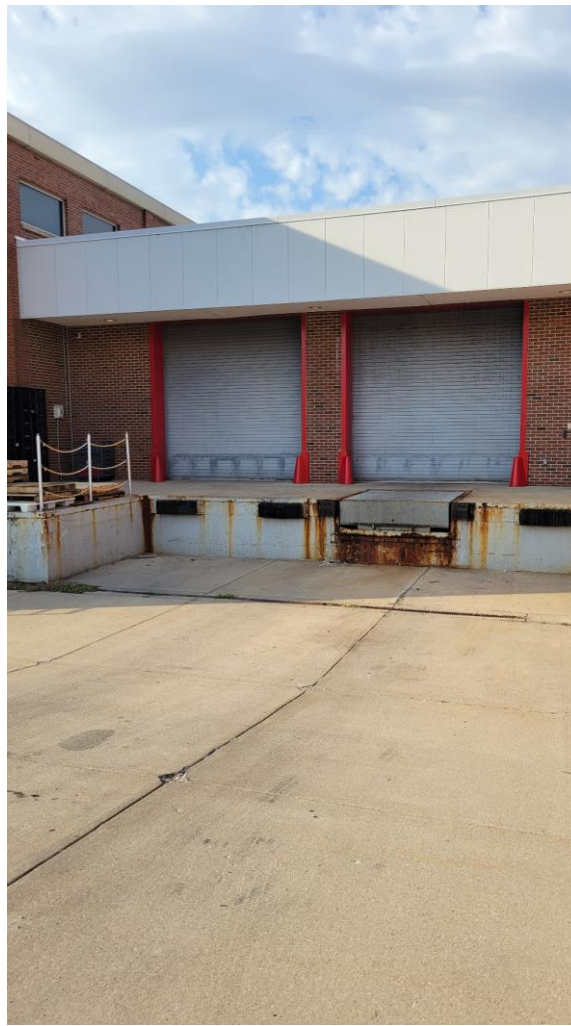
Rusting dock leveler and cracks in the concrete at the loading dock

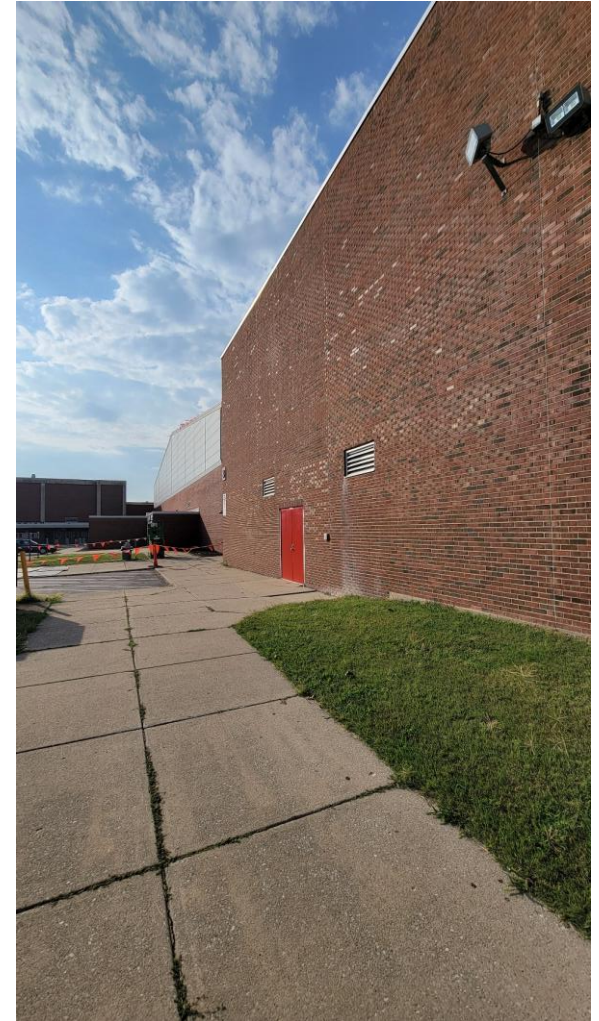
Some wear and tear of the concrete sidewalks

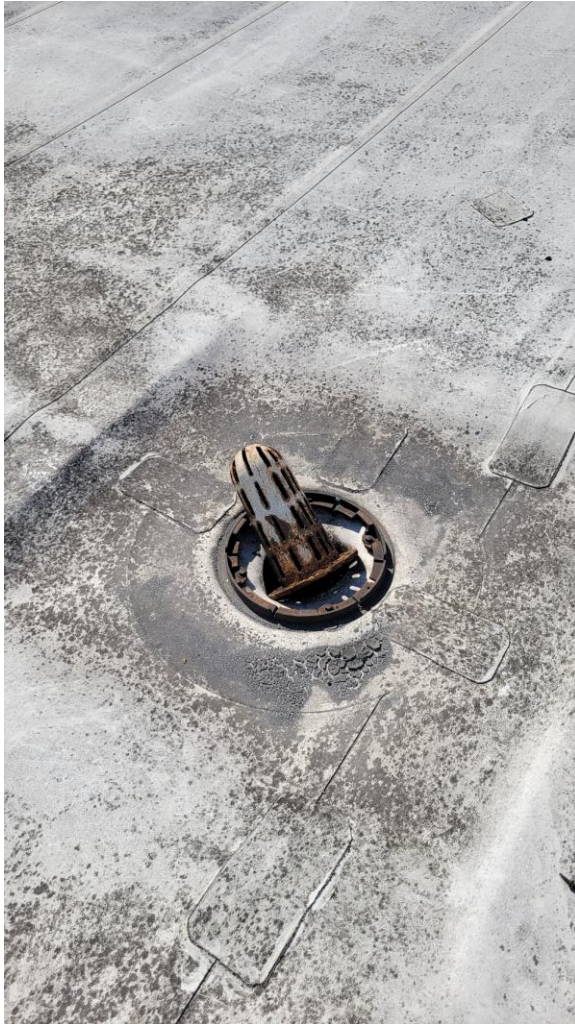
Single roof drain, no overflow
