Report to Perry Township Schools School Board

High Schools Facility Assessment

Perry Township Schools

January 17, 2025

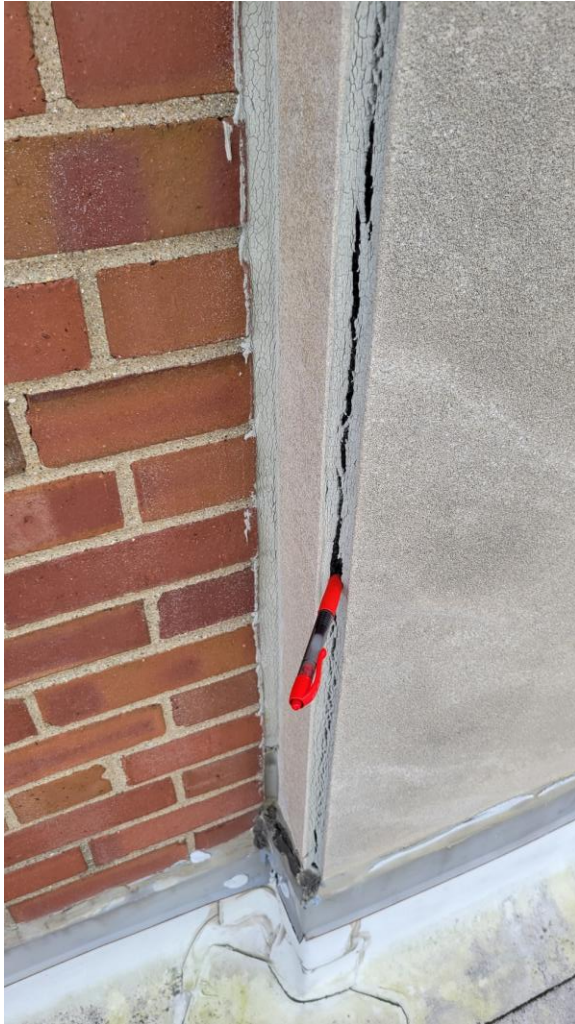
Failing caulk joint

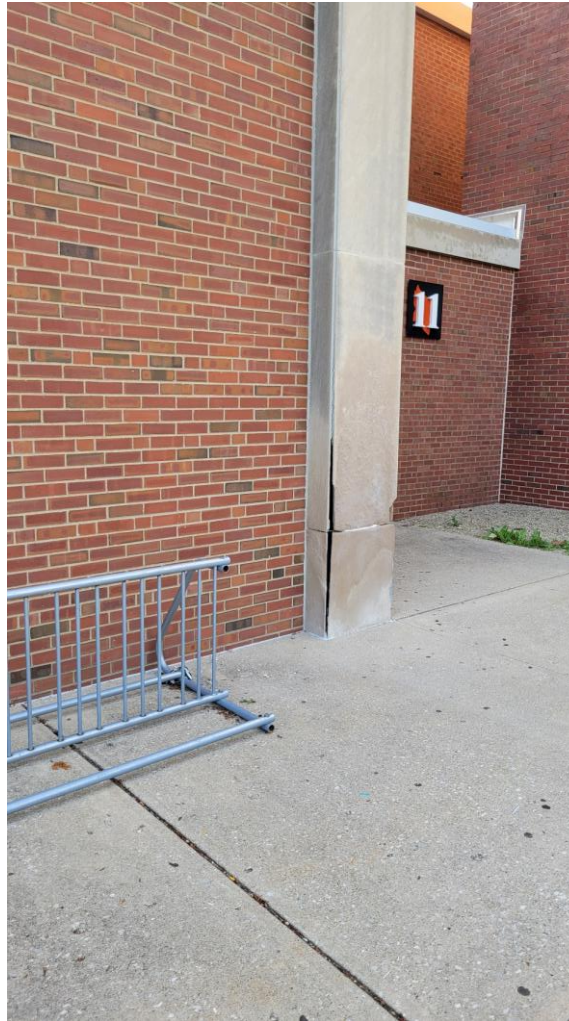
Failing limestone veneer outside auditorium

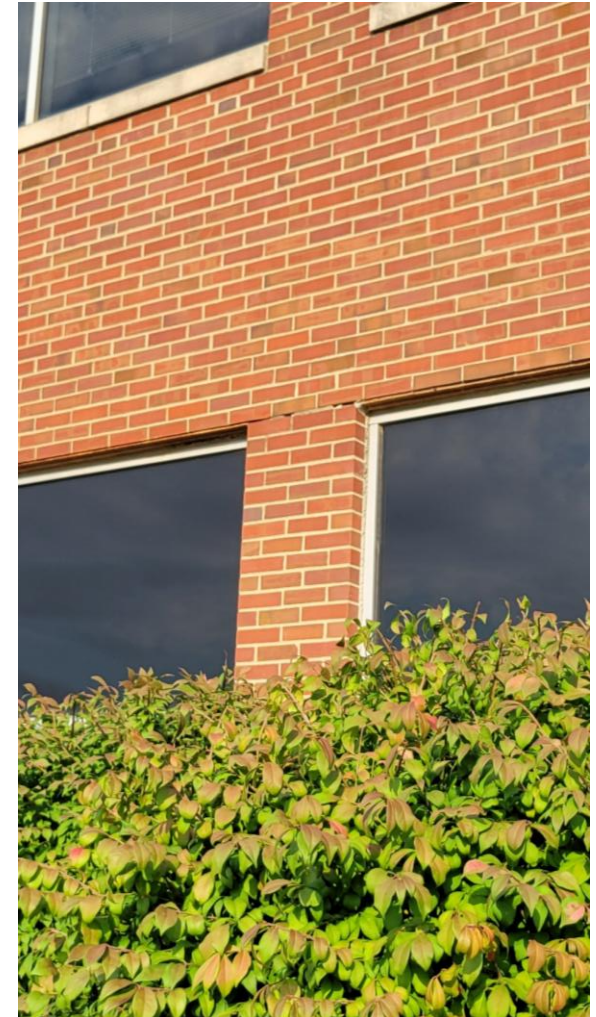
Failing grout joint at the head of windows on the west side

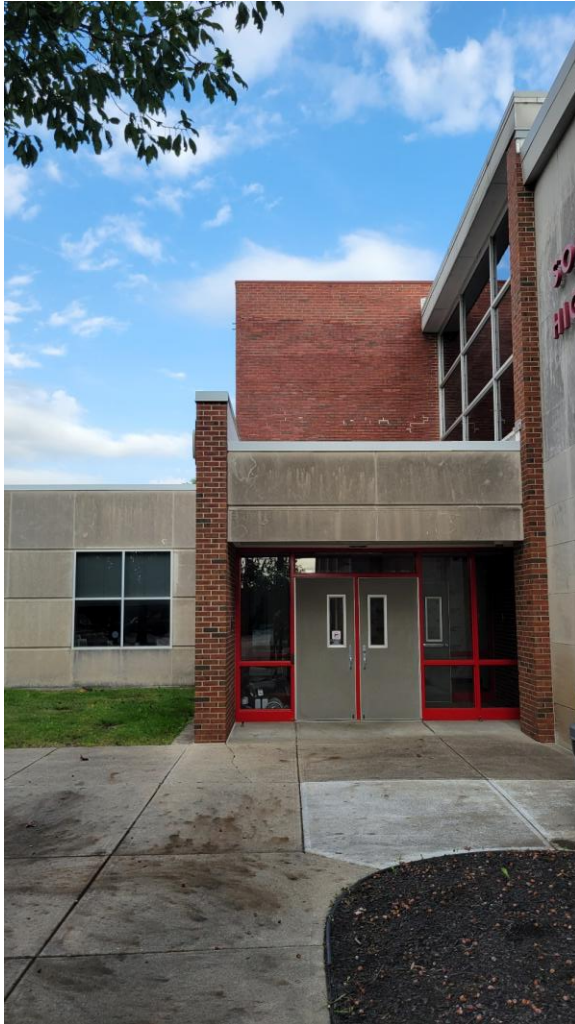
Some brick moisture issues above the lower roof

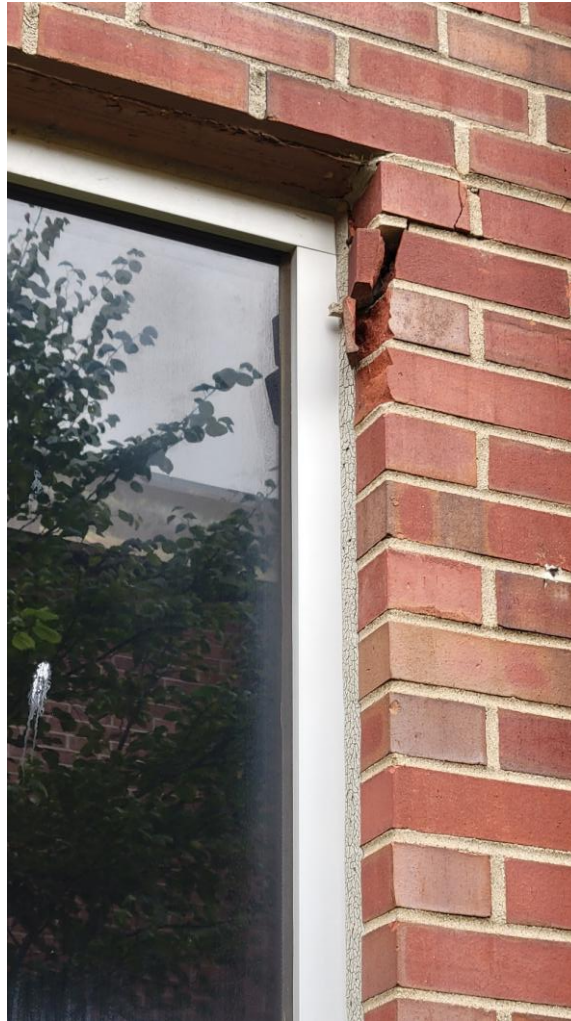
Window head condition at the courtyard

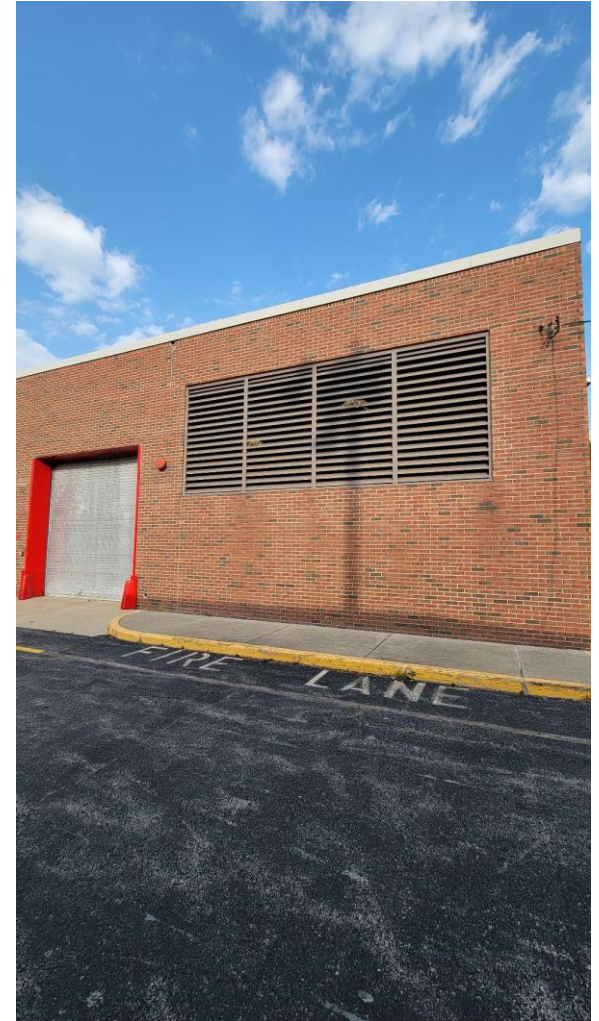
Birds' nests in the louvers on the south side of the building

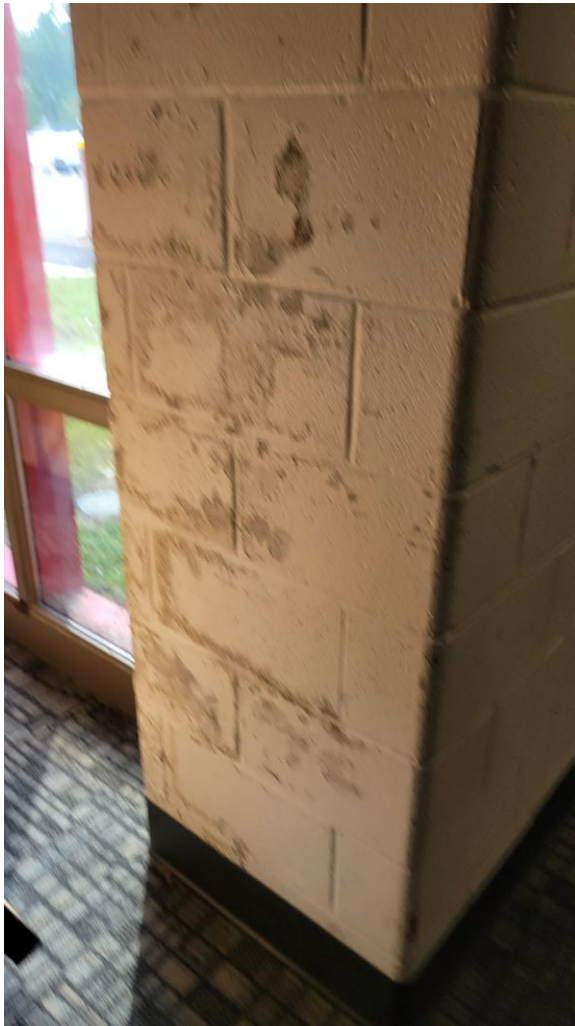
Moisture infiltration inside the building

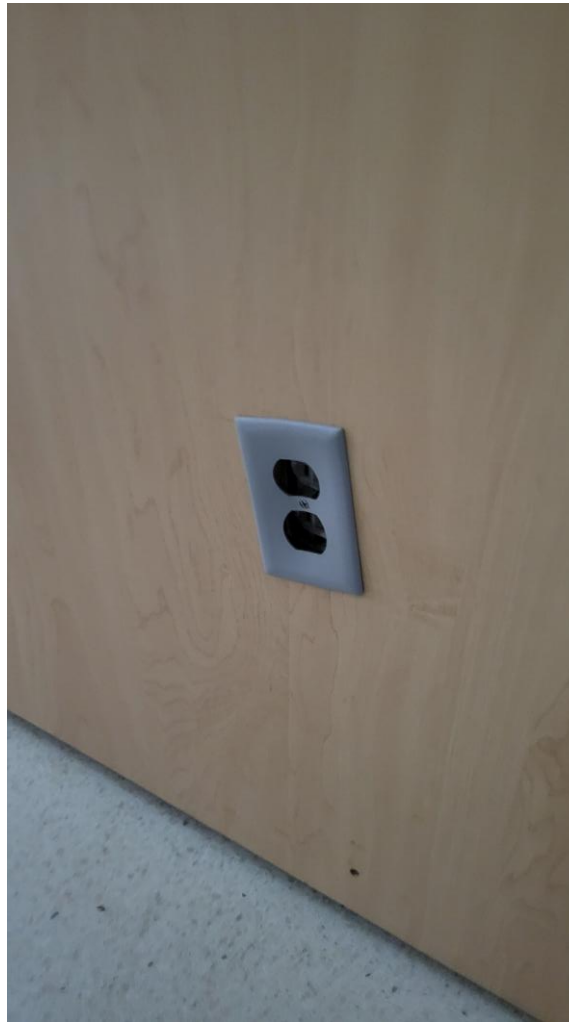
Plywood wall veneer is pulling away from the wall in the cafeteria (possible water infiltration from the courtyard)

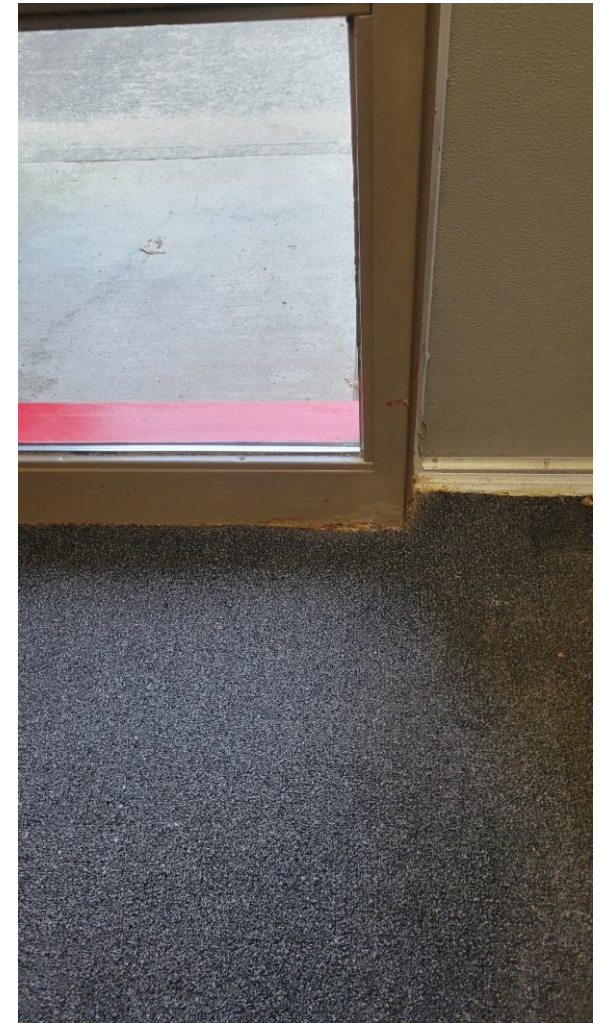
Some exterior hollow metal doors and windows are rusting

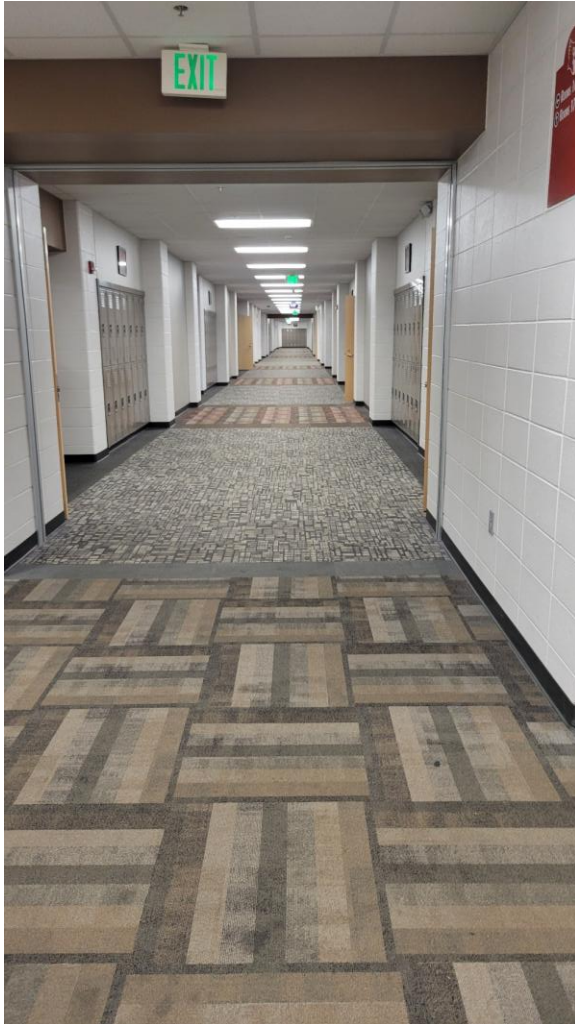
Stained carpet tile

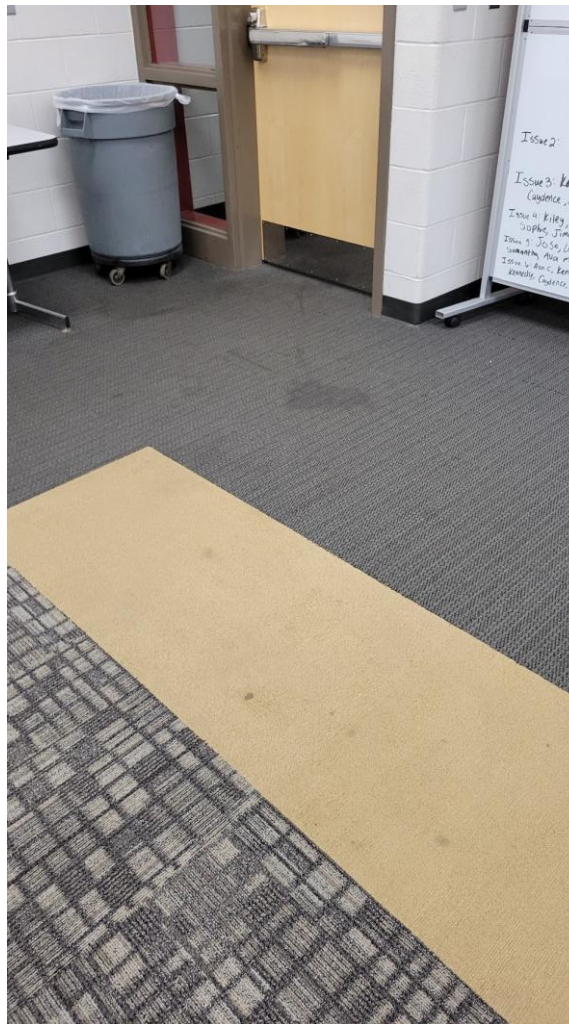
Stained carpet tile

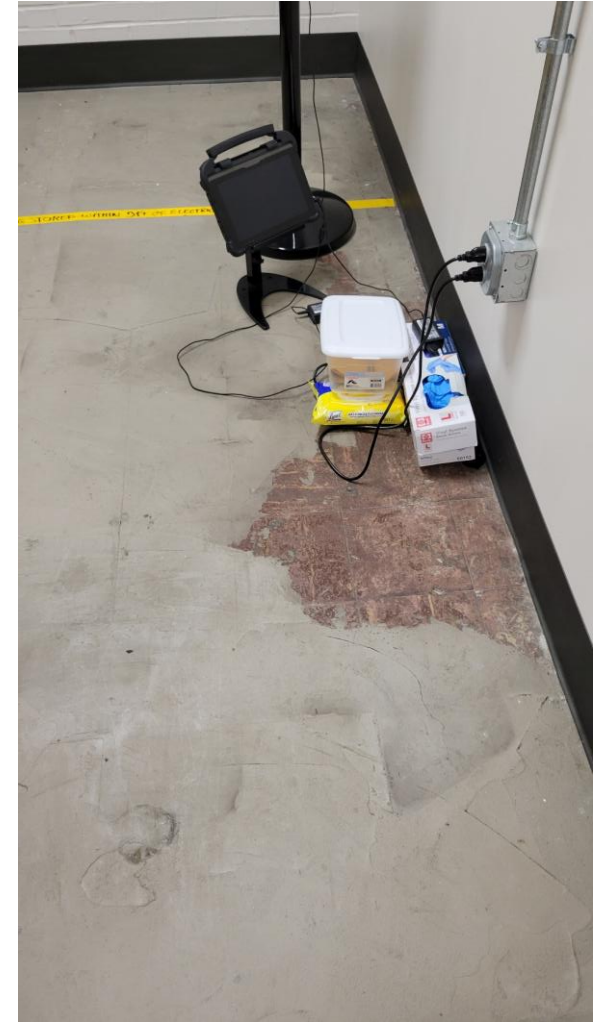
Storage room floor tiling visible under the skim coat

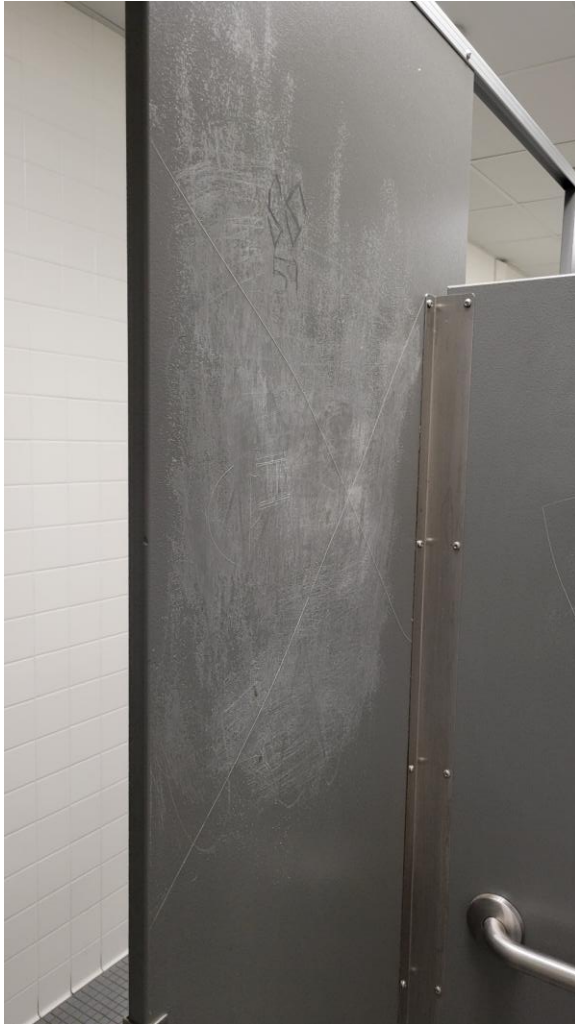
Damaged toilet partitions

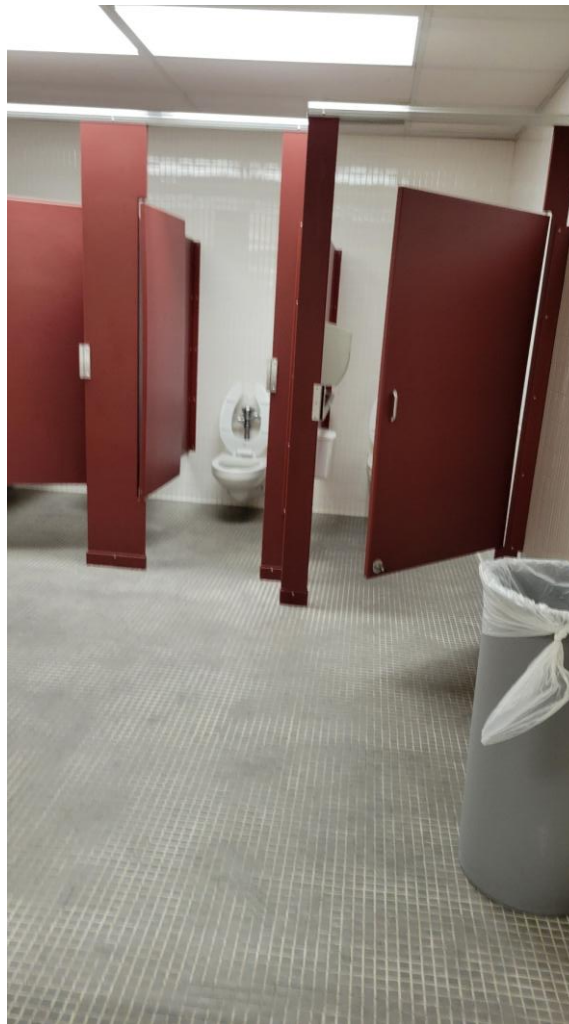
ADA non-compliant stall at a staff restroom

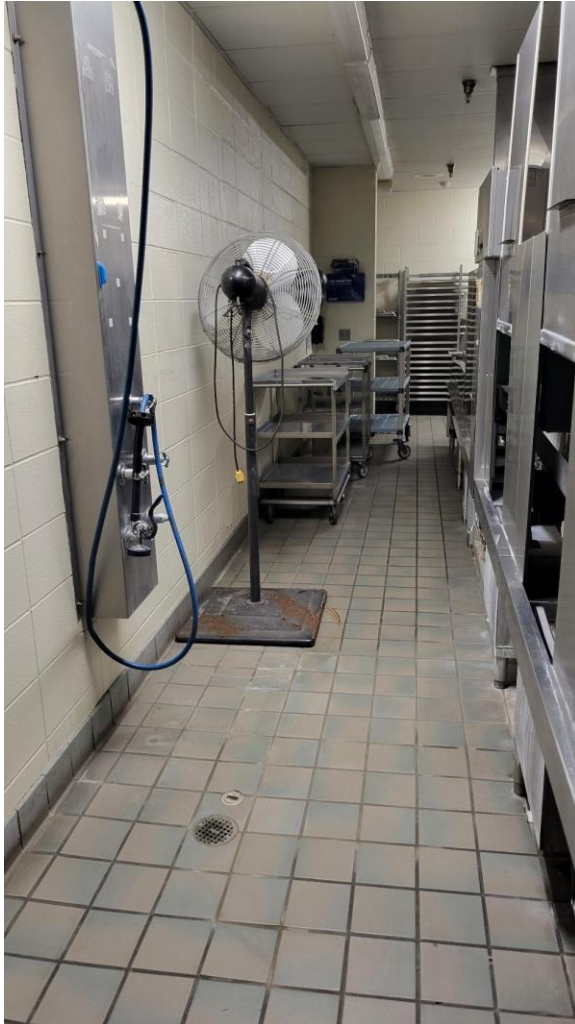
Fans in the dishwashing room. No air supply registers were observed during the site visit

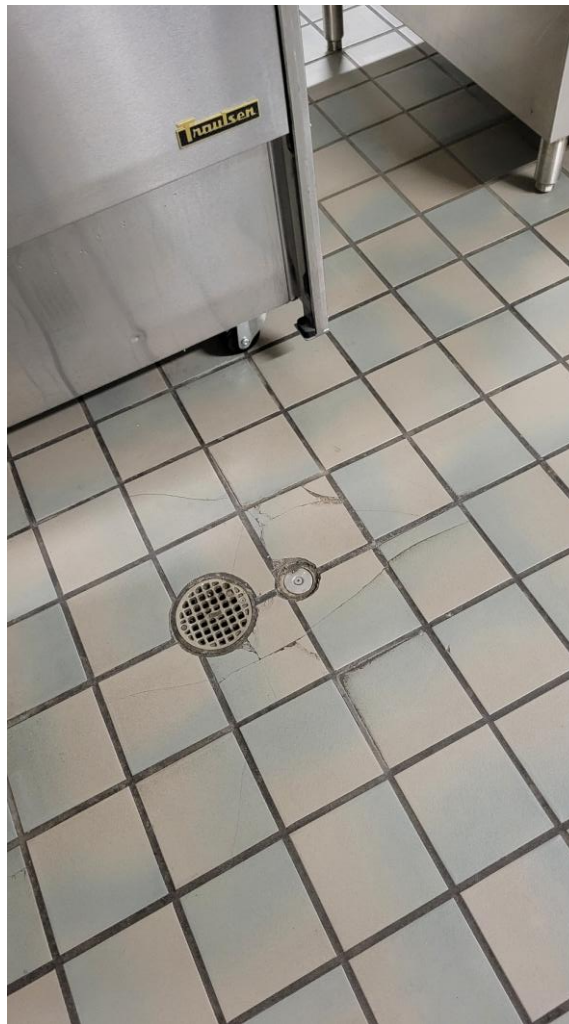
Cracked floor tile in the kitchen

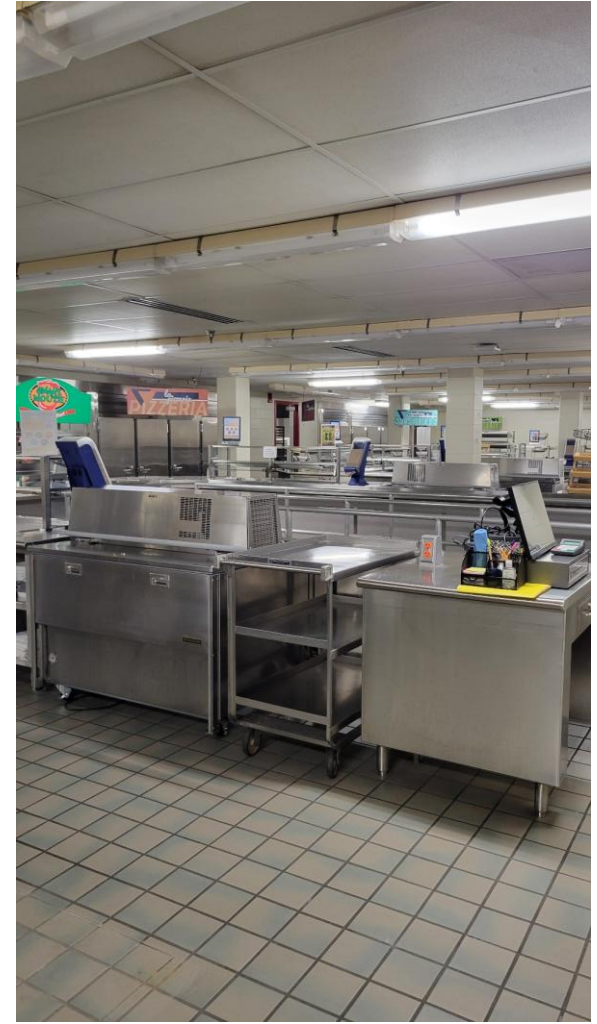
Outdated serving area layout

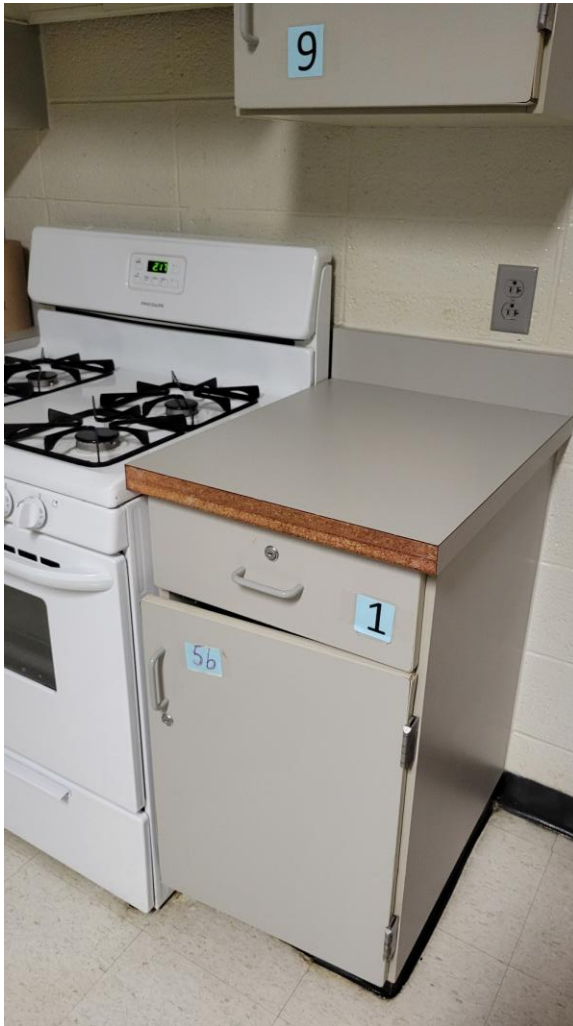
Missing plastic laminate edging in FACS

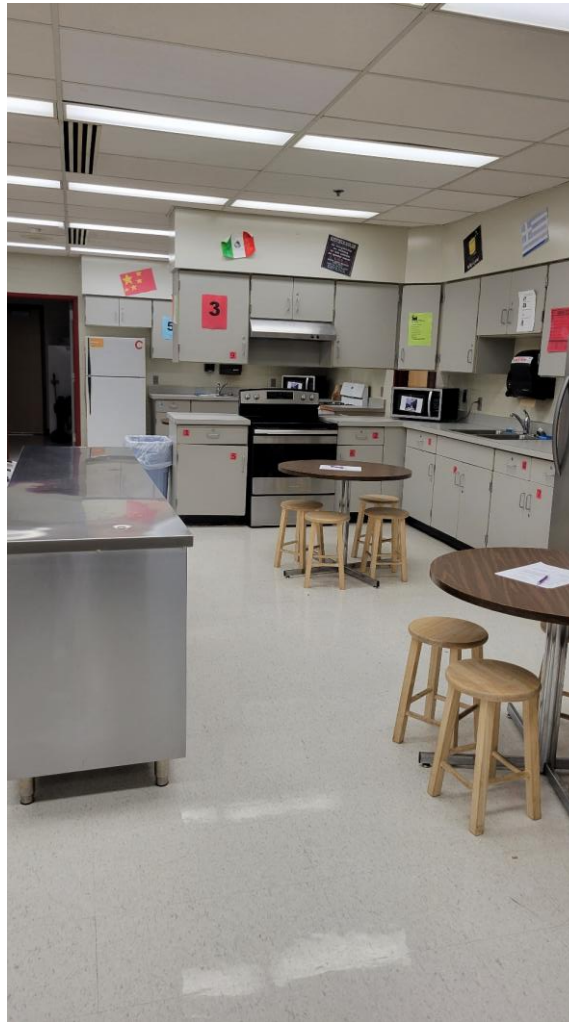
Outdated FACS room layout , no ADA station

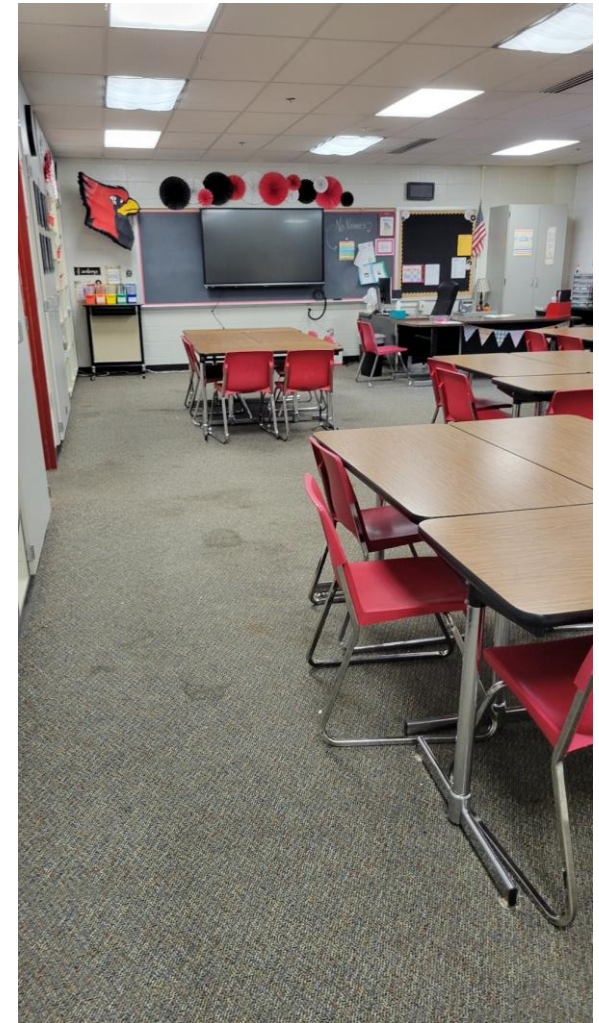
FACS lecture room stained carpet flooring and chalkboard

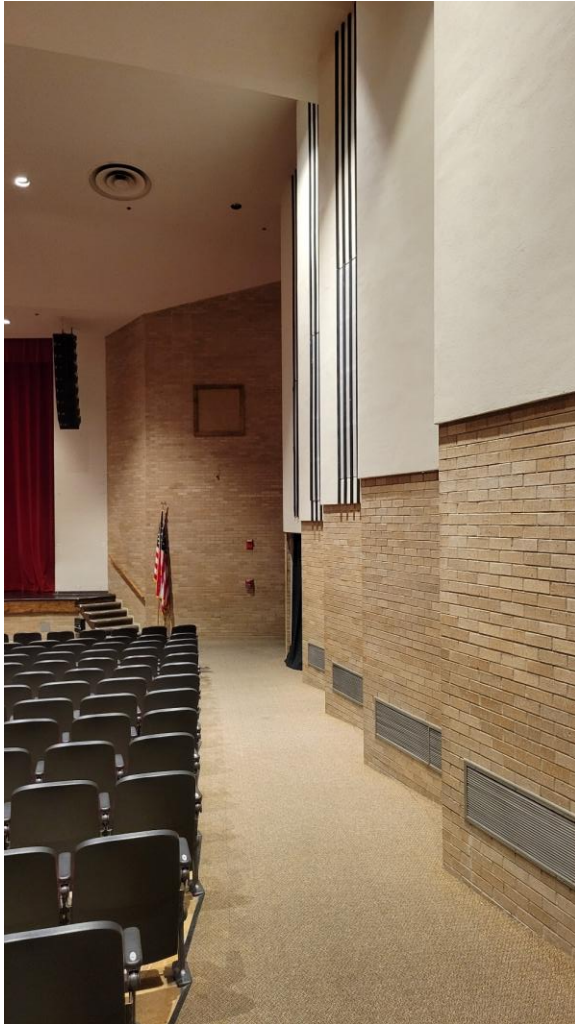
No emergency lighting in Auditorium

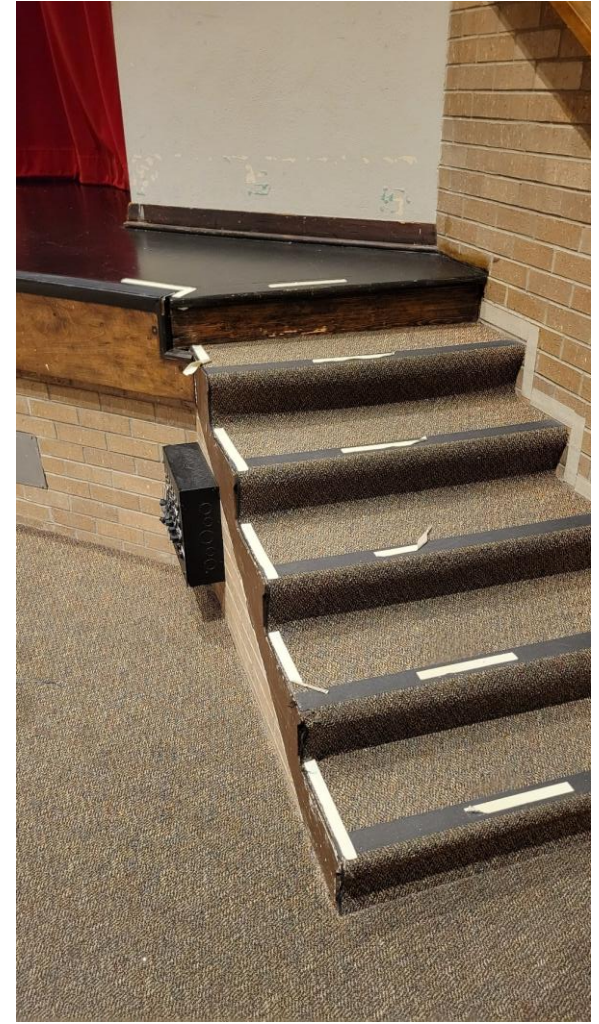
Worn carpet on stage stairs

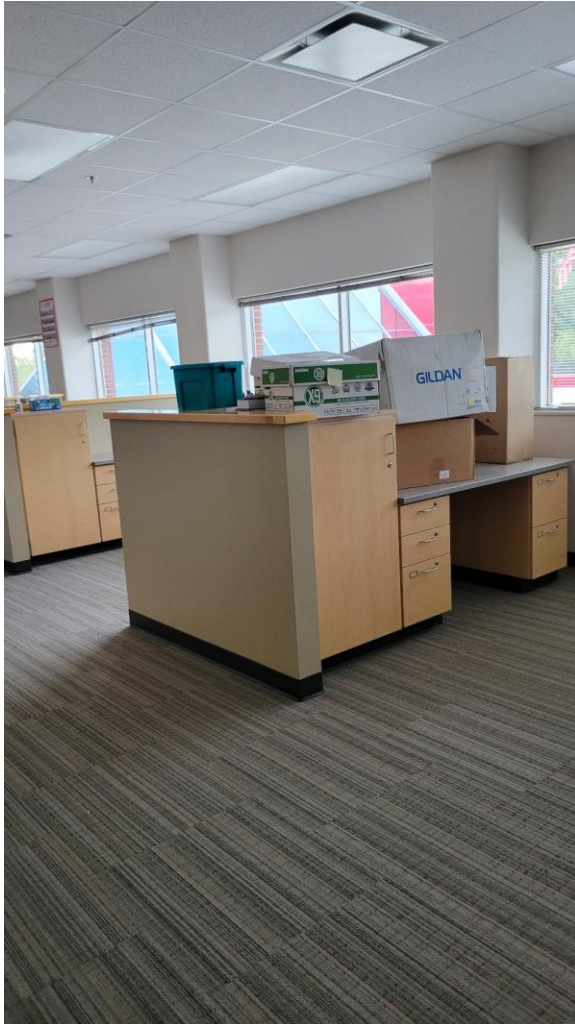
Underused office space on the second floor

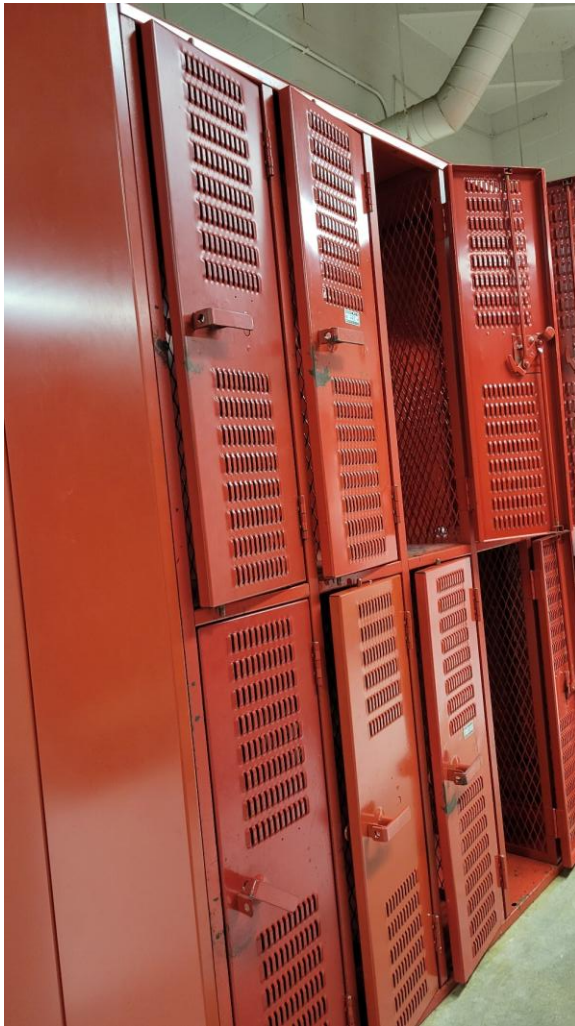
Worn lockers in the locker rooms

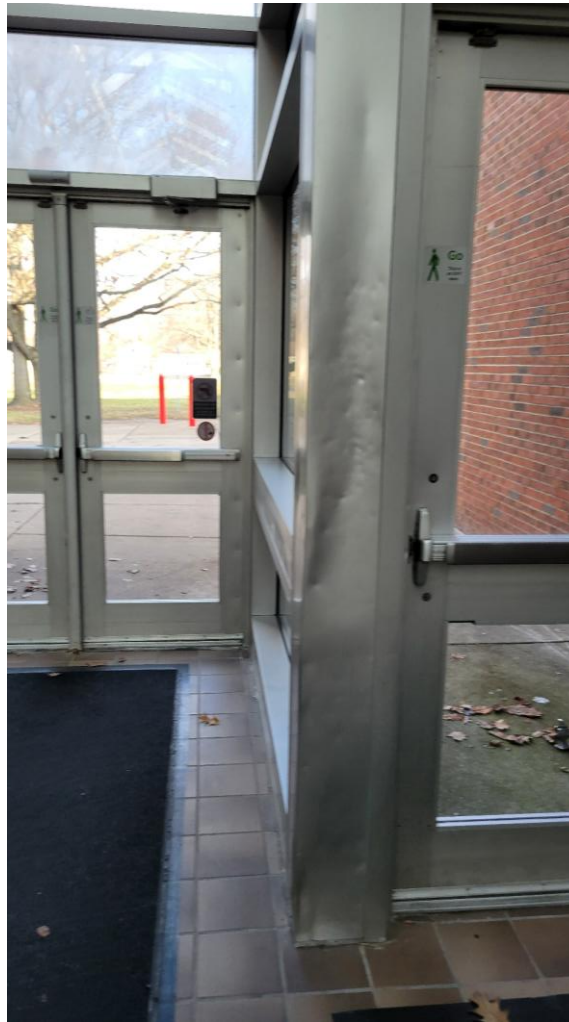
Damaged vestibule framing at pool entrance
