Report to Perry Township Schools School Board

High Schools Facility Assessment

Perry Township Schools

January 17, 2025

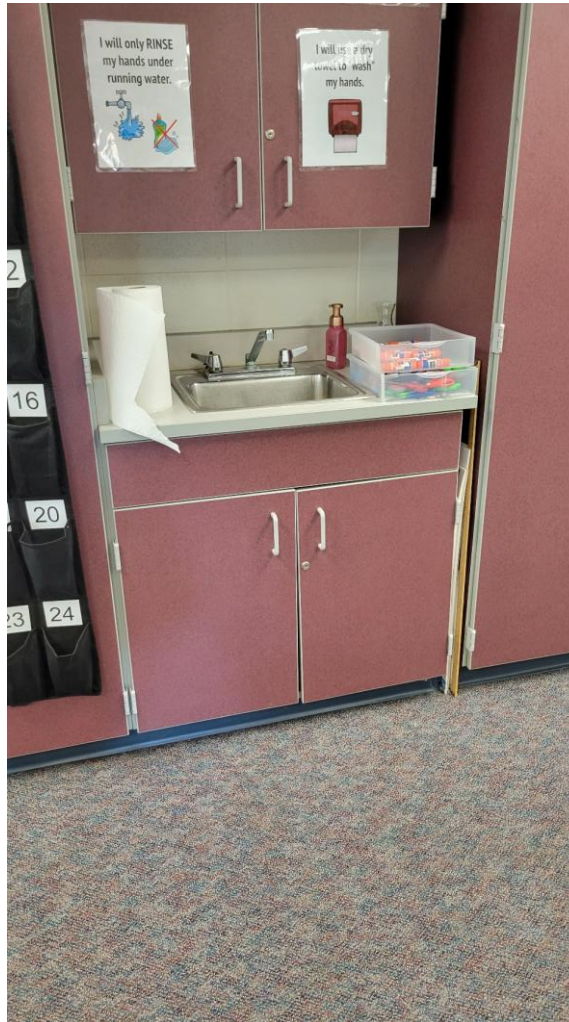
Non-ADA sink height

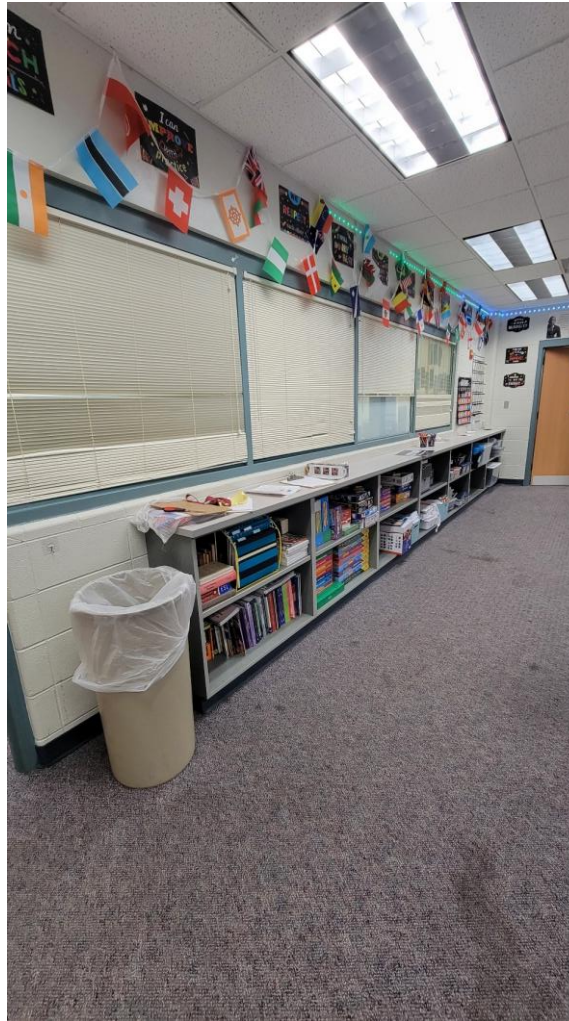
Classroom separated by thin window partitions upstairs

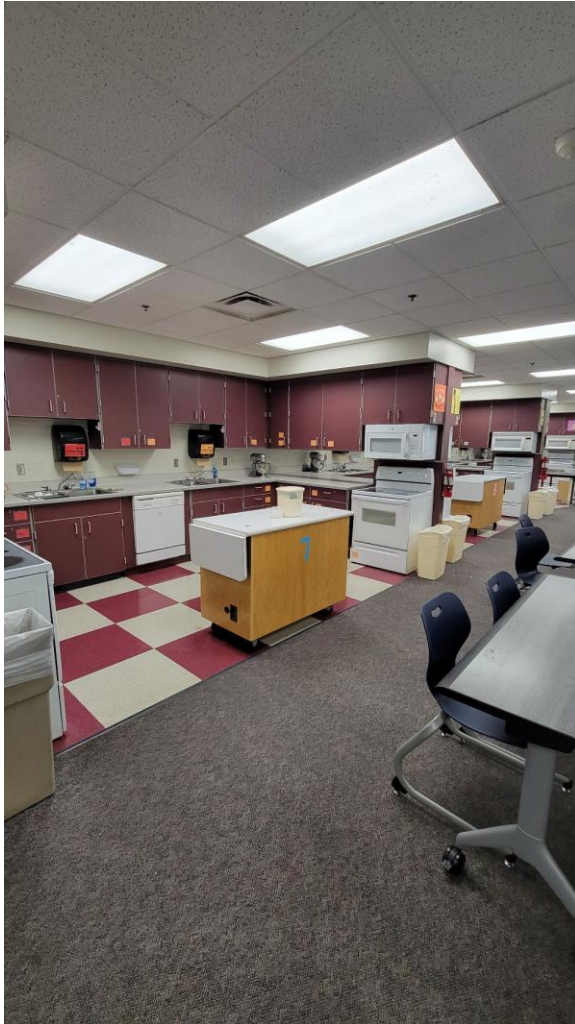
Outdated home economics with poor visibility into individual kitchens

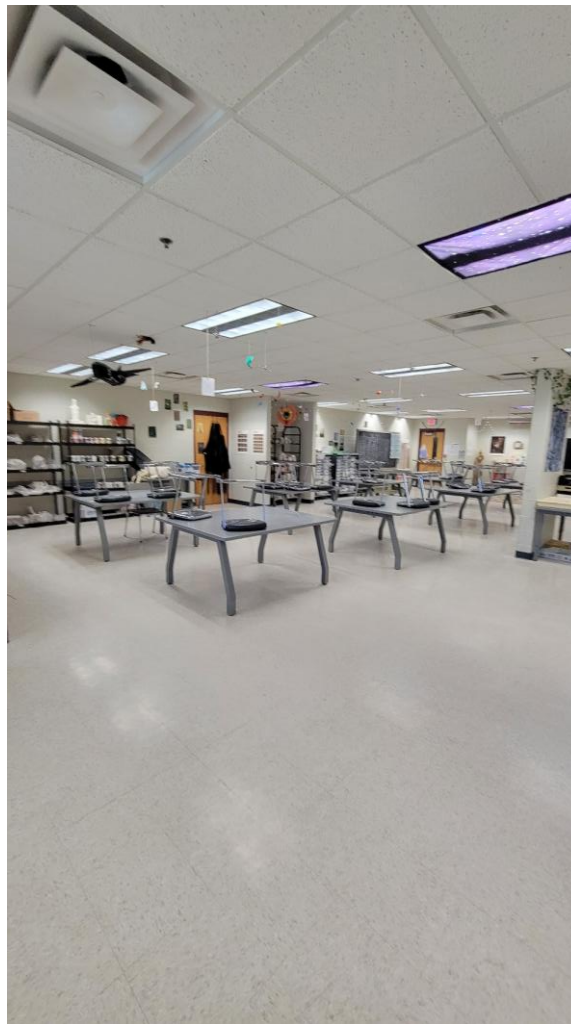
Classroom retrofitted to be an art classroom with no sink

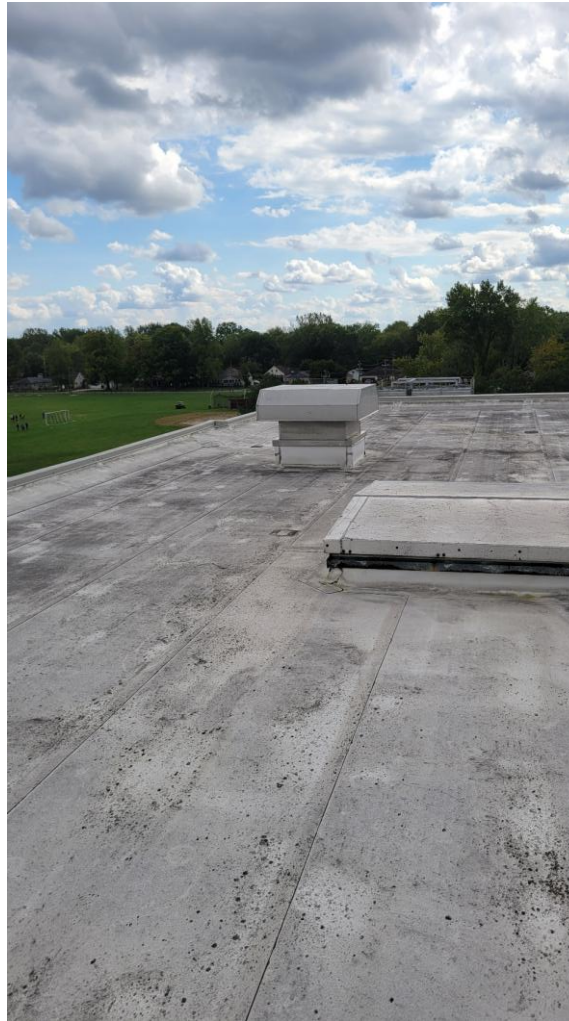
Aging roof

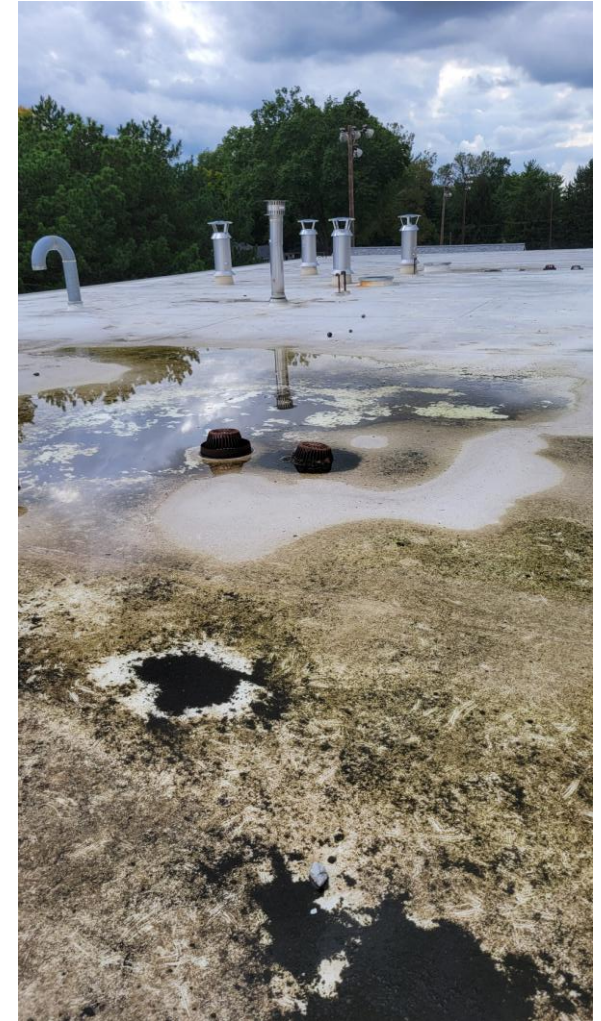
Ponding on the roof

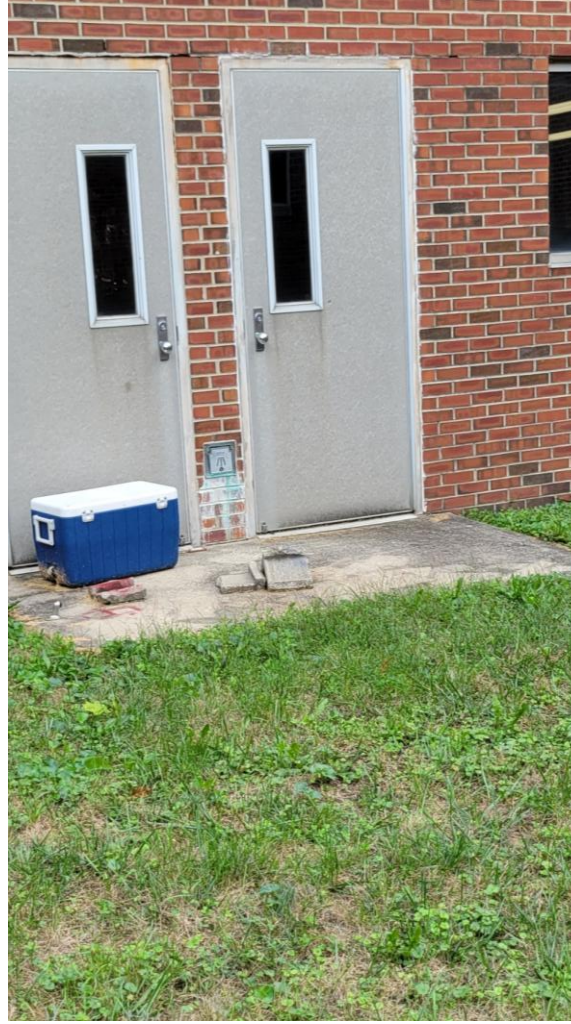
Non-ADA door handles

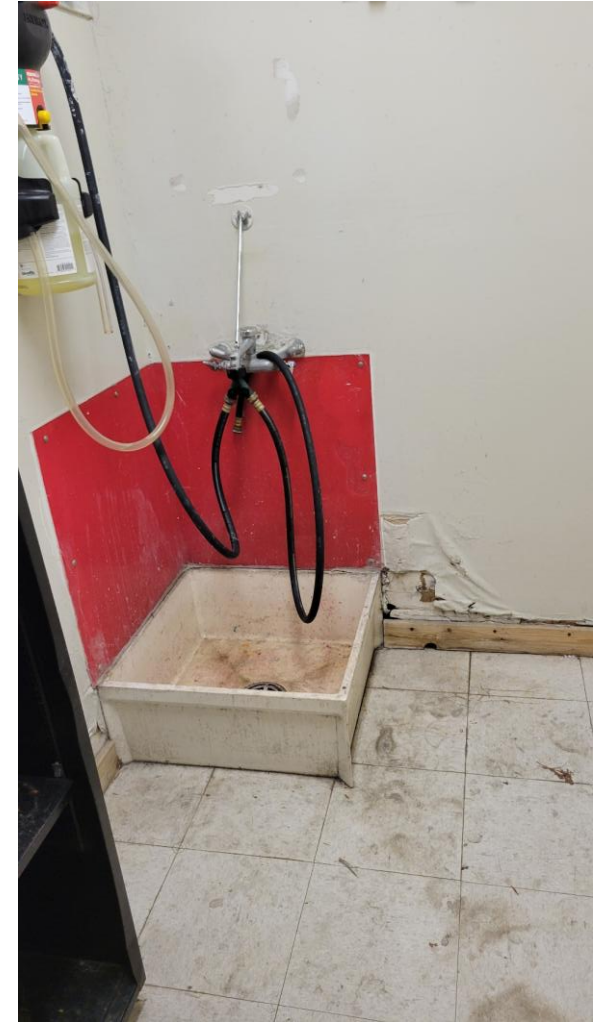
Gypsum board wall in not protected around the mop sink

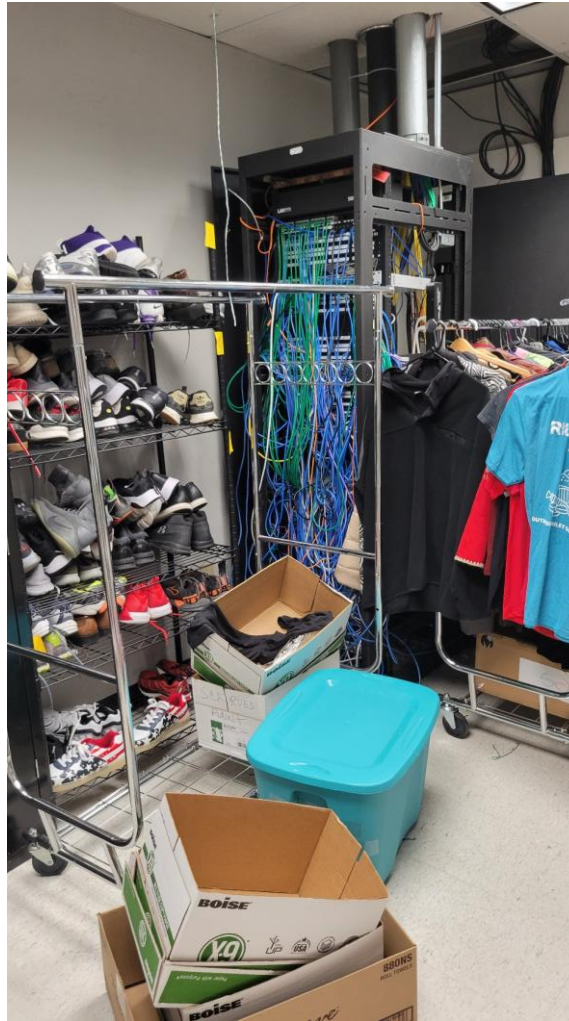
Stored items in the IDF closet
